Tensioner problems

Different tensioning pulleys depending on design of crankshaft drivesprocket (round or oval) Various Ford/ PSA/ Volvo 1.6L diesel (Part nos. CT1162K2/ K3/ K4 and WP2/ WP3/ WP4)

Incorrect setting of the tensioner pulley can cause engine damage PSA 1.6 HDi / BlueHDi, Ford 1.5 TDCi (Part nos. CT1203, CT1203KI, CT1203WP1)

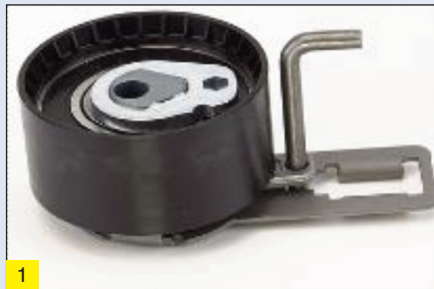
Different vehicle manufacturers use different timing belt kits, with three different tensioning pulleys (V56664, V56675, V56676) that all look the same (Fig. 1). The catalogs usually list two different timing belt kits for each vehicle, with the selection depending on the year of manufacture. However, the year is not always a reliable way to determine which is needed. To make sure, check the shape of the crankshaft drive sprocket (oval or round design). Installing the wrong kit may result in noise or, in the worst case, failure of the belt drive.

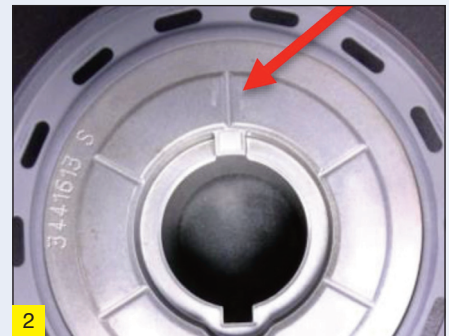
Different tensioning pulleys have different tension spring rates. The rate must be suitable for the crankshaft drive sprocket installed at the factory. In recent years, the manufacturer has brought in an optimised timing drive with an "oval" sprocket. The two designs of sprocket look the same at first glance. To see which it is, take it off and check whether there is a recess drilled in the back (Figs. 2 and 3).

For the crankshaft sprocket with no recess (round design, Fig. 2), always use the timing belt kit CT1162K2/ WP2 with tensioning pulley V56664. If the sprocket has a recess (oval design, Fig. 3), you need either kit CT1162K3/ WP3 with tensioning pulley V56675 or kit CT1162K4/ WP4 with tensioning pulley V56676. If both kits are listed for the vehicle, it is the year of manufacture which is the decisive point. To be sure, check the part number on the back of the tensioning pulley.

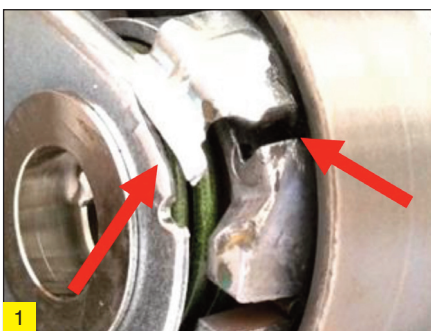
Teeth have been sheared off the timing belt, the tensioner pulley arrester body is torn and the full load stop is incorporated (Fig. 1).

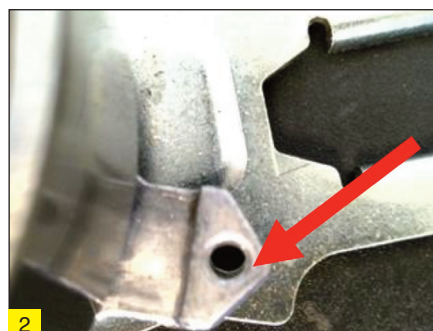
During the tensioning procedure, the hole in

the tension indicator is brought into contact with the hole in the arrester body. As a result, the tension is set far too high and the full load stop is incorporated by the recurring clash with the arrester body until it finally tears or aborts (Fig. 2).
