## An incorrect setting of the tensioner pulley can cause engine damage

PSA 1.6 HDi / BlueHDi, Ford 1.5 TDCi (article no. CT1203, CT1203K1, CT1203WP1)

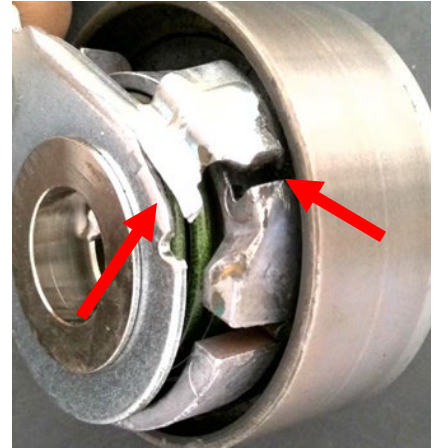
Teeth have been sheared off the timing belt, the tensioner pulley arrester body is torn and the full load stop is incorporated.

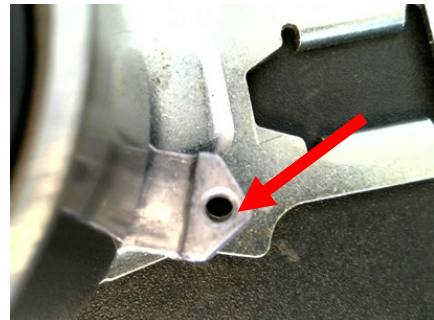
During the tensioning procedure, the hole in the tension indicator is brought into contact with the hole in the arrester body. As a result, the tension is set far too high and the full load stop is incorporated by the recurring clash with the arrester body until it finally tears or aborts.
