Ford EcoBlue 2.0 Litre timing belt issues

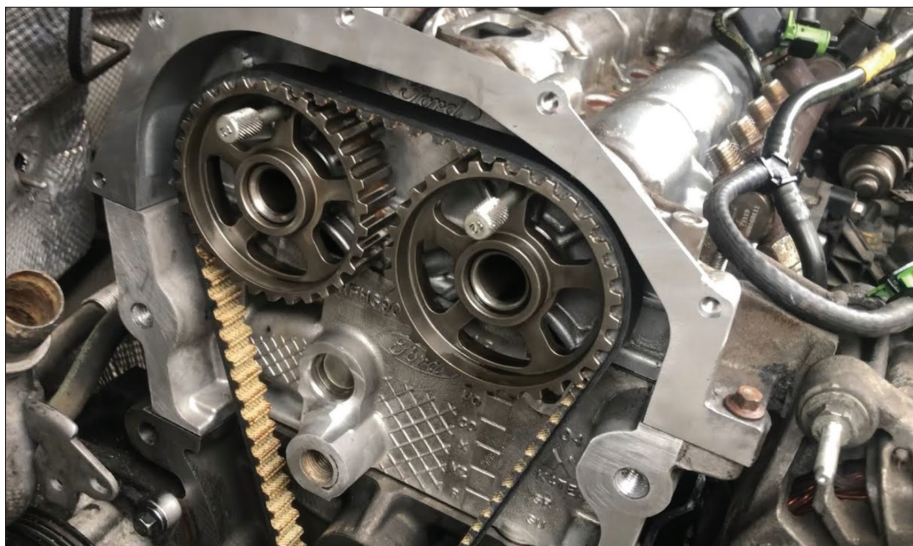
The Ford EcoBlue 2.0 litre engine uses a belt in oil (BIO) timing belt that requires increased vigilance and has some variations in best practice servicing
