Getting timing belt tension right

Problems persist with the premature failure of the belt and tensioner on the 1.7-litre turbo diesel engine used in many Vauxhall/Opel and Isuzu vehicles. Following the prescribed belt and tensioner change instructions is key to making sure it doesn't happen to you, Dayco explains.

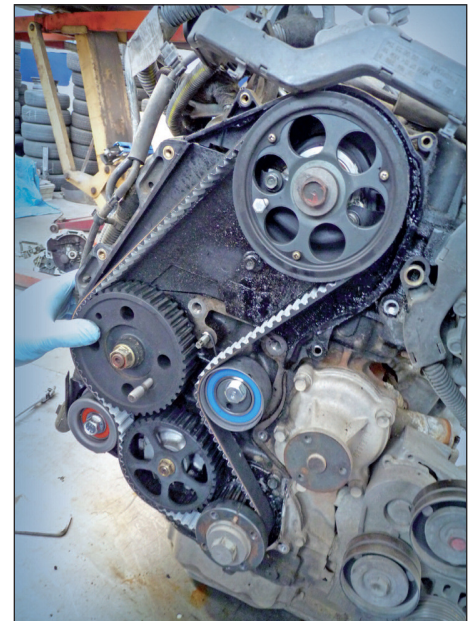
To simplify the process further, technicians can use a Dayco Tensiometer, which will ensure the correct tension is achieved. The tool is easy to use and just needs the relevant test code for the belt application to be entered and the belt vibrated. If the test reading is 'OK' the belt is fine, but if the result reads + or - three, the belt will need to be
