Audi A3 gear lever position sensor failure

Audi A3 Fault Malfunctions in the gear lever position sensor

Several instances of faults in the AUDI 7-speed Direct-Shift-Gearbox (DSG) gearboxes affecting the A3 (8P1) model have been seen by the Eure!Car technical helpline.

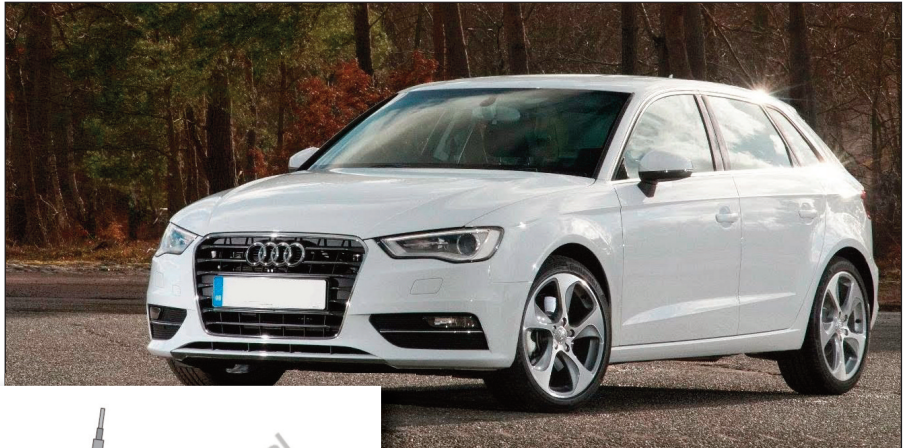
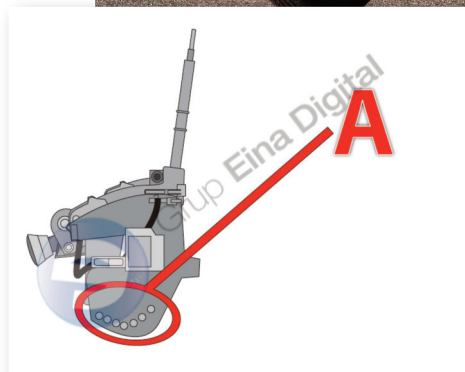
NOTE: The description of fault codes P1730 and P1731 may confuse a mechanic into believing that the code is referring to the gear lever and the corresponding sensor inside the group of 16 Hall sensors (see image A), which is designed to detect the position of the gear lever itself.

If the correct operation of the DSG gearbox is known, it can be understood that codes P1730 and P1731 refer to the travel sensors of the forks inside the gearbox to carry out the gear change.

There is a fault in the position or travel sensor of the affected gear or described in the fault code itself. The cause of the defect is due to the presence of metal

particles caused by wear of the internal gearbox components. This happens because the lubricating oil of this system also circulates inside the mechatronic valve circuit. If fault code P1604 occurs, the mechatronic unit has been damaged beyond repair.

- Read the fault codes in the gearbox control unit using the diagnostic tool
- Confirm that the cited fault code is recorded in the symptom field of this technical note
- Replace the mechatronic unit with a new one
- Clean the travel sensors for each gear, and its opposing magnet
- Replace the gearbox lubrication oil .
