Eure!Car Tech Blog highlights

Mondeo IV adaptive headlight fault

Peugeot 107, Citroën C1 and Toyota Aygo Power steering problem

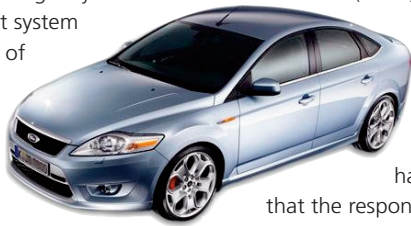
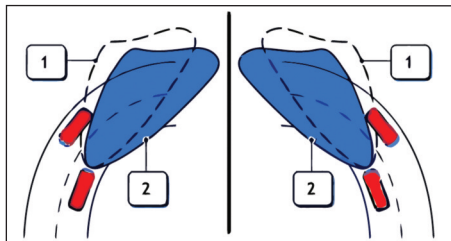
1 - Headlamps with the AFS system
2 - Without the AFS system

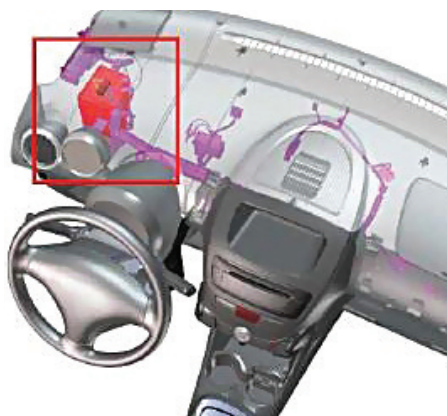
The EPS can be accessed by removing the top of the dash

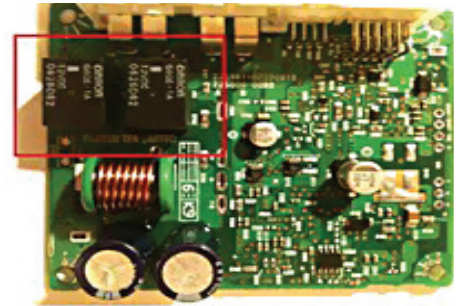
These relays supply power to the power steering unit and the electric steering motor

The printed circuit of the power steering unit has two relays (see image above). These two relays supply power to the power steering unit and the electric steering motor.

Replace the two relays of the power steering unit named above. The reference of these is: OMRON G8QE-1A 12V DC
