Eure!Car Tech Blog highlights

Mondeo IV adaptive headlight fault

Peugeot 107, Citroën C1 and Toyota Aygo Power steering problem

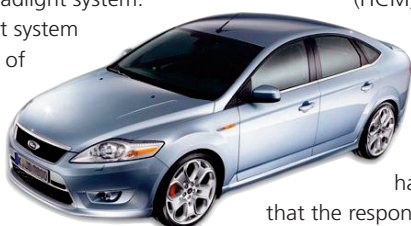
This anomaly is caused by a calibration software fault in the headlight control module (HCM). After clearing the fault codes, reprogramme the HCM unit with the most up to date software.

- Malfunction message for the AFS system's front lights on the instrument panel display.
- The lights are positioned permanently in the centre.
- Code B1D68 is recorded (Left headlamp swivelling feedback sensor) or B1D69 (Right headlamp swivelling feedback sensor) in the headlight control module (HCM).

To assure yourself that the incident has been resolved, check that the response of the adaptive headlight system (AFS) is correct, with no fault messages on the instrument panel display, and the headlights have changed their position.

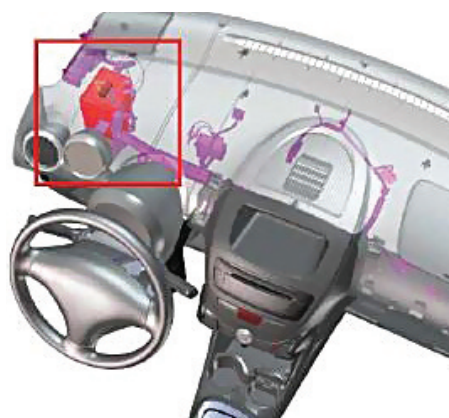
The EPS can be accessed by removing the top of the dash

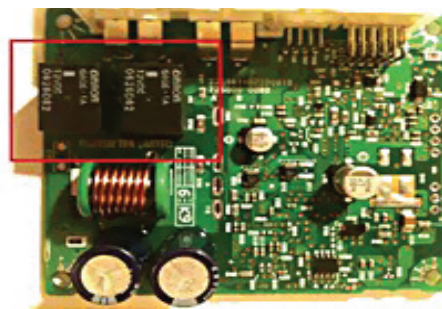
These relays supply power to the power steering unit and the electric steering motor

The printed circuit of the power steering unit has two relays (see image above). These two relays supply power to the power steering unit and the electric steering motor.

Replace the two relays of the power steering unit named above. The reference of these is: OMRON G8QE-1A 12V DC
