Eure!Car Tech Blog highlights

Peugeot 206 and 206+

Instrument panel faults

Peugeot 107, Citroën C1 and Toyota Aygo Power steering problem

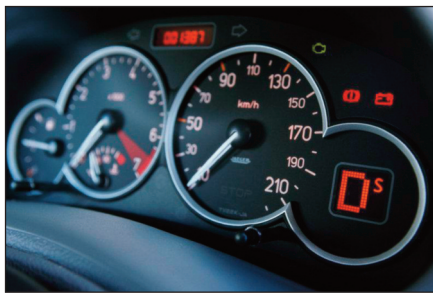
The majority of the faults in the clocks and indicators are caused by malfunctioning of the stepper motors that rotate the needles. These break and cease to function or malfunction, possibly working in fits and starts.

If problems in the vehicles installation are ruled out after testing, the affected panel can be replaced by a new one, bearing in mind that this must be encoded, or the instrument panel can be sent to a specialised centre for checking and repair.

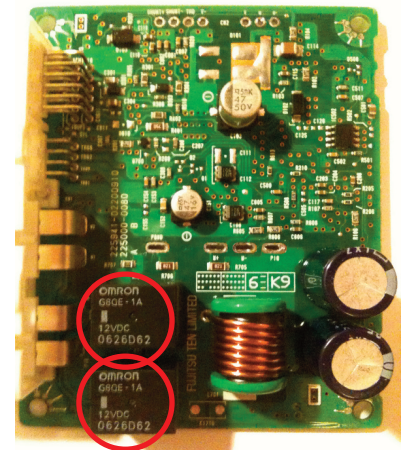
The printed circuit of the power steering unit has two relays (see figure). These two relays are responsible for supplying power to the power steering unit and the electric steering motor.

The potentially faulty relays are circled

Replace the two relays of the power steering unit named above.

The reference of these is: OMRON G8QE-1A 12V DC
