Eure!Car Tech Blog highlights

Combo/Corsa 1.3 CDTi with Z13DT Engine Chronic DPF Regeneration Failure

Astra H 1.9 CDTi with Z19DTH Engine Difficulty shifting, stalling

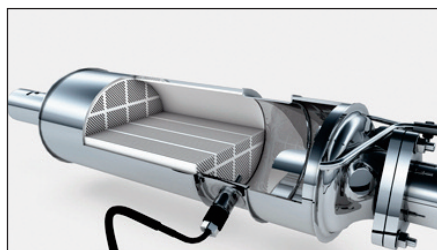
If a majority of the above symptoms are found, the cause may be serious damage inside the engine, due to severely diluted oil that has lost its properties as a lubricant. This is due to the large number of times that DPF regeneration has not been successfully completed. The interruption of DPF regeneration occurs in vehicles that are driven very short distances, or in continuous city driving cycles.

The first thing to do in this case is to inspect the damage to the engine, and carry out the necessary repairs. They will vary depending on how long the vehicle has had the fault.

After repairing all of the affected mechanical parts, clear all of the DTCs, run the engine to make certain none of the DTCs have returned. After all of the DTCs have been cleared, you can start a forced regeneration of the DPF, or replace it. In the event of this fault, the engine control unit must be reprogrammed.

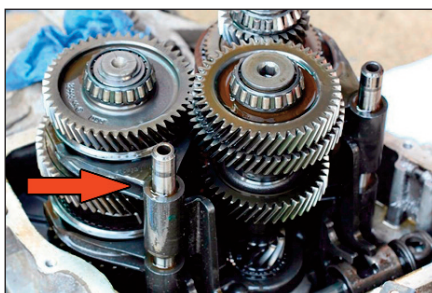
It is likely that the gear selector fork between 3rd and 4th gear is bent. In our experience, the most common cause of this incident, is a defect in the 3rd to 4th gear selector fork. The fork can deform and cause this fault. The solution involves replacing the defective fork

The deformed gear selector fork, at arrow

The replacement procedure involves removing the gearbox and then the housing cover, by unscrewing the 16 bolts that secure it to the gearbox. The joint area must be cleaned with a gasket remover liquid or spray.

Disassemble the reversing light switch and remove the gearbox in order to be able to work comfortably. Engage neutral, remove the selector lever and extract the input shaft. At this point, remove the 3rd to 4th gear selector fork. Best practice before the replacement of the fork requires cleaning the thread burrs of the 16 holes in the gearbox housing and cleaning the swarf that remains. This ensures there is no foreign material inside the gearbox that could cause future damage. It is recommended to clean the housing magnet.

Replace the fork with the correct modification and follow the assembly process for the input shaft, not allowing it to twist and preventing the forks from resting on the linking sleeve. Fit the reversing light switch, tightening it to 20 Nm.
