# Eure!Car Tech Blog highlights

## **Combo/Corsa 1.3 CDTi with Z13DTH Engine Chronic DPF Regeneration Failure**

## **Astra H 1.9 CDTi with Z19DTH Engine Difficulty shifting, stalling**

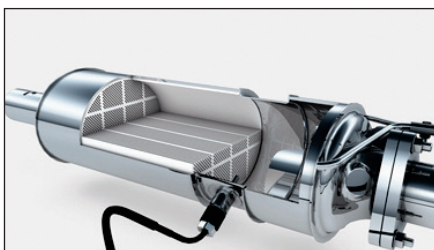
If a majority of the above symptoms are found, the cause may be serious damage inside the engine, due to severely diluted oil that has lost its properties as a lubricant. This is due to the large number of times that DPF regeneration has not been successfully completed. The interruption of DPF regeneration occurs in vehicles that are driven very short distances, or in continuous city driving cycles.

The first thing to do in this case is to inspect the damage to the engine, and carry out the necessary repairs. They will vary depending on how long the vehicle has had the fault.

After repairing all of the affected mechanical parts, clear all of the DTCs, run the engine to make certain none of the DTCs have returned. After all of the DTCs have been cleared, you can start a forced regeneration of the DPF, or replace it. In the event of this fault, the engine control unit must be reprogrammed.

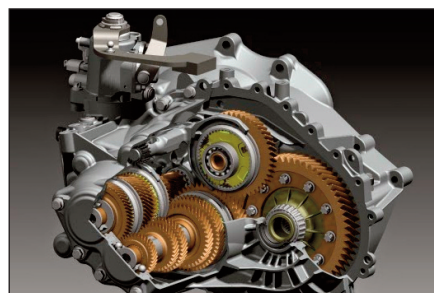
Some Opel Astra H 1.9 CDTi cars with Z19DTH engines experience difficulty in engaging first gear, do not move forward after engaging third gear and the engine stalls on releasing the clutch pedal in 1st gear.

The first thing that must be ruled out as a cause of this problem is a defect in the selection mechanism, between 1st and 3rd gear, as these can engage simultaneously and generate the described symptoms. It is likely that the fault is caused by an internal problem inside the gearbox.

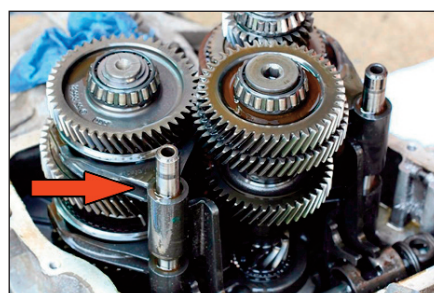
It is likely that the gear selector fork between 3rd and 4th gear is bent. In our experience, the most common cause of this incident, is a defect in the 3rd to 4th gear selector fork. The fork can deform and cause this fault. The solution involves replacing the defective fork

The deformed gear selector fork, at arrow

The replacement procedure involves removing the gearbox and then the housing cover, by unscrewing the 16 bolts that secure it to the gearbox. The joint area must be cleaned with a gasket remover liquid or spray.

Disassemble the reversing light switch and remove the gearbox in order to be able to work comfortably. Engage neutral, remove the selector lever and extract the input shaft. At this point, remove the 3rd to 4th gear selector fork. Best practice before the replacement of the fork requires cleaning the thread burrs of the 16 holes in the gearbox housing and cleaning the swarf that remains. This ensures there is no foreign material inside the gearbox that could cause future damage. It is recommended to clean the housing magnet.

Replace the fork with the correct modification and follow the assembly process for the input shaft, not allowing it to twist and preventing the forks from resting on the linking sleeve. Fit the reversing light switch, tightening it to 20 Nm.
