Eure!Car Tech Blog highlights

This new post discusses the details of a common failure in VAG TSi engines, timing chain stretch and/or loss of crank/camshaft synchronisation.

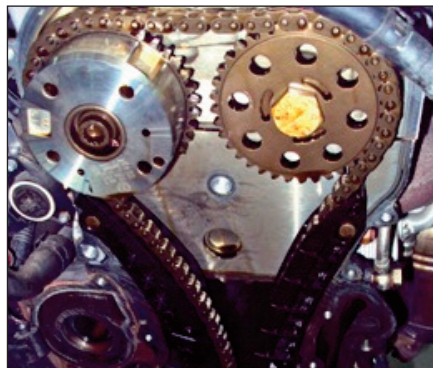
The problem may be caused by the stretching of the timing chain, or even loss of synchronisation, which it is caused by a mechanical failure of the chain tensioner.

When the engine stops, the tensioner loses oil pressure, leaving the timing chain slack at the bottom of the crankshaft. When restarting, a lack of synchronisation with the camshafts may occur.

Slack timing chain between the camshafts

If the chain needs replacing, use a complete timing chain kit with a new hydraulic tensioner. Ensure that the modified model is installed. The two hydraulic tensioners are shown to the right on this page. Check for any other damage that may have occurred inside the engine. Loose or broken parts may have caused other damage that may have to be repaired.

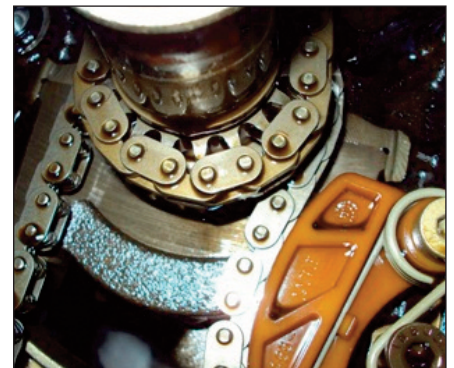
In extreme cases, when starting the engine, the crankshaft sprocket may rotate without pulling the chain, causing major

Slack timing chain at the crankshaft sprocket

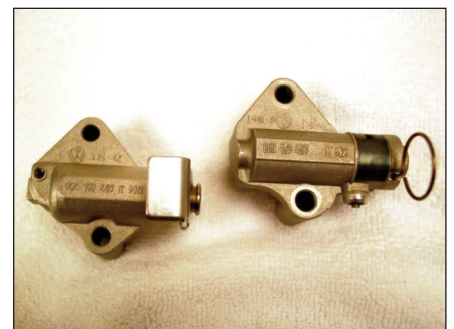
Hydraulic tensioners, the old design (on right) and modified (on left)

Replace the tensioner of the timing chain every 60,000km and make sure that the modified tensioner is part of the timing chain kit.
