# Eure!Car Tech Blog highlights

## Kia Sorento and Santa Fe Engine jerks or stops during driving.

### Difficulty or Delay in Warm Start-up in VAG Group Vehicles

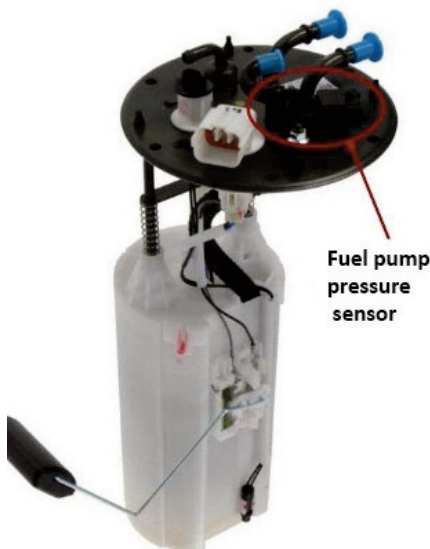
- Check the condition of the fuel filter. In these vehicles the replacement period is 30,000 km.
- Check the pressure of the injection rail. Power, earth and signal of the injection rail pressure sensor when the engine is working properly is shown below:
  - PIN1: Ground
  - PIN2: Sensor signal (0.5 Volt on contact /

- 1.2 Volt with idling engine / 2.4 Volt with engine at 3,000 rpm)
- PIN3: 5 volt power supply.

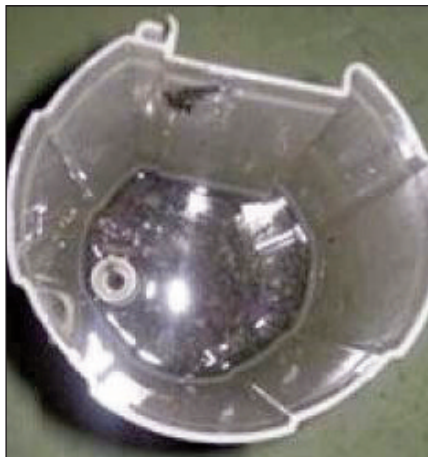
Access the fuel gauge located under the rear seats. Check that there is no dirt or shavings inside the fuel tank. In these models, there is a problem with the paint that coats the inside of the fuel tank; its loosening causes the generation of waste, interfering with the fuel intake of the fuel pump.

Paint sludge inside the fuel pump assembly

Clean the inside of the fuel tank, the gauge and the incorporated filter. Replace the fuel filter and also the pressure sensor within the fuel pump itself.

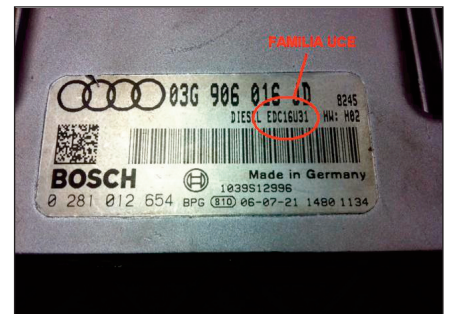
The affected engine control units are made by BOSCH and they belong to the EDC family: EDC16.U1, EDC16.U31 and EDC16.U34.

The ECU type can be read of the label

You have to reprogramme the ECU in order to restore the default settings. In this way, the vehicle will start again at the correct crankshaft revolutions specified by the manufacturer.
