Assembly instructions for replacing wheel bearings/hub

Manufacturer:
Volvo

Model: 850, C70, S70, V70 I

FAG 0001

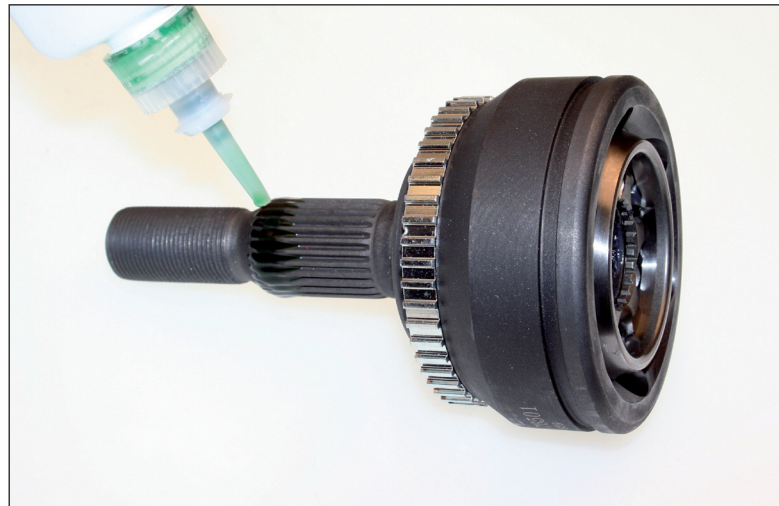
Fig. 1

Vibrations and or knocking noises after fitting the wheel bearing / hub.

The splined drive shaft is loctited into the hub as standard. After re-installation of the splined drive shaft without loctite there may be some play between the hub and the splined drive shaft.

Secure the splined drive shaft with a suitable metal adhesive loctite (e.g. Volvo part number **1161370**) into the hub.

- Clean the spline on the hub and the splined drive shaft.
- Apply a **3-4 mm** bead of the loctite around the outer edge of the straight spline (see **fig. 1**).
