Technical Bulletin

Mazda 2.2 D - TCK246NG & TCK330NG

TB0048

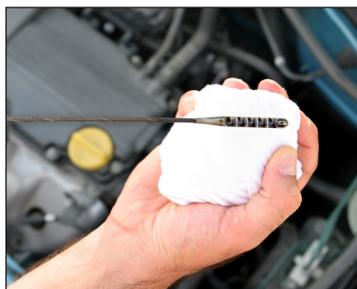
Cause: Oil contamination **Effect:** Worn engine components

Due to a Diesel Particulate Filter (DPF) maintenance process, designed by Mazda, the models listed above are prone to fuel ingress into the lubrication system. Small amounts of fuel pass the piston rings into the sump, in a process called 'fuel-wash', degrading the engine oil in the process.

The result of this issue affects all moving engine components. Wearing the piston rings and the high-stress components, such as the timing chain assembly. As the oil degrades it loses its' lubricating and hydraulic properties, resulting in reduced performance, premature wear and eventual component failure. To prevent these issues occurring, FAI recommends you follow the advice below.
