# Rover Group

200 / 400, Mini, Metro, Maestro, Montego

CATB 0001

## AUTO ADJUST CLUTCH CABLE ISSUES

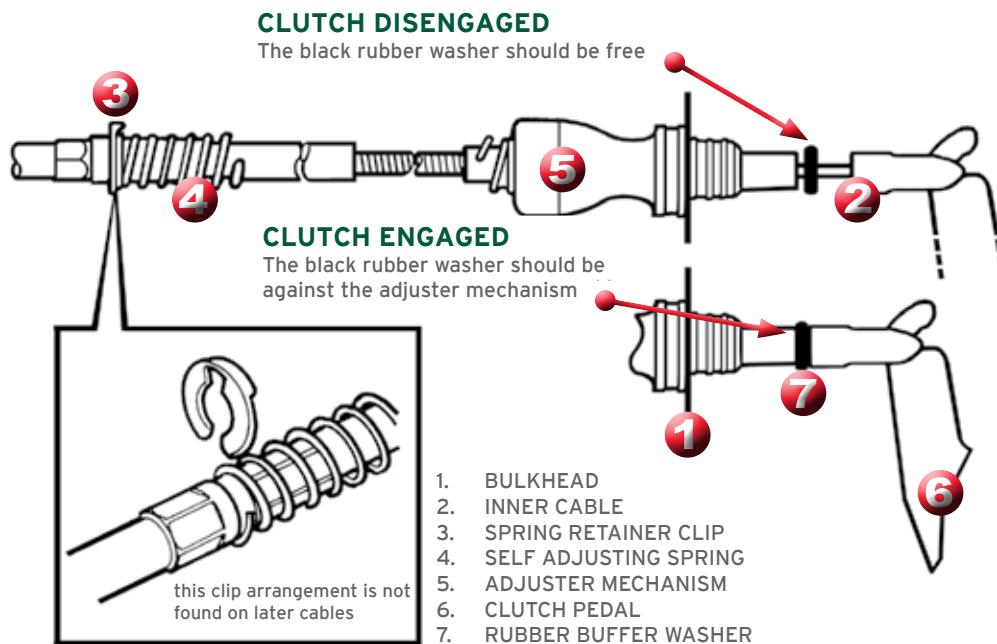
Clutch engagement whilst pedal is still very close to floor and also a common cause of slip/premature wear to the driven plate facings. This can be due to failing action of the auto-adjust mechanism.

Make sure that the auto adjust mechanism is correctly located in the bulkhead and that the ends of the cable have been located in the gearbox lever and to the top of the clutch pedal. The spring C clip should be fitted if required as per the illustration below.

Check that when the pedal is at rest, that the rubber buffer washer can press against adjuster mechanism tube whilst still having some upward movement left before striking the pedal return stop. If not it may be due to too much slack in the cable, you may have to help it initially by holding the adjuster mechanism body with one hand and with the other hold around the self adjust spring moving them apart. (This will take out any slack.)
