Range Rover, Range Rover Sport
MK.3, 2005 > 2009

COTB 0019

Auxiliary Coolant Pump Failure Due To OE Wiring Fault

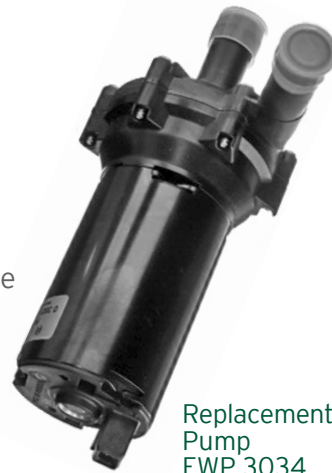
Replacement Pump
FWP 3034

Cause When the vehicle was manufactured the wires that go into the pump connector (C3006) may have been wired the wrong way round. Because of this the auxiliary coolant pump, which cools the supercharger, will run backwards. Over time this will degrade the pump and cause it to fail or run very poorly. Land Rover have recognised this problem and issued a technical bulletin, number LBT00041.

Please Note: If the Auxiliary Coolant Pump has been operating in a state of reverse, then it is recommended that the pump is replaced.
