Opel / Vauxhall / Suzuki

FWP 1787, FWP 2078, FWP 2194

COTB 0018

Impellor Fouling Cylinder Block

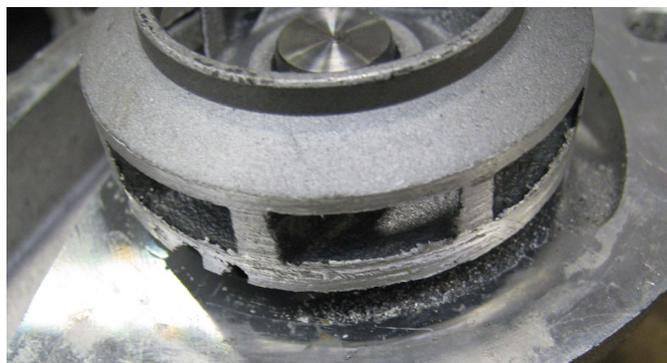
It would appear that when the old water pump is removed from the engine the two locating dowels remain in the old pump body rather than retained in the cylinder block. When the new pump is then installed on the engine block it fails to locate correctly due to the absence of the dowels.

damaged impellor as a result of no locating dowels being fitted!

When replacing the water pump it is essential therefore to remove the dowels from the old pump and refit to the cylinder block before installing the new pump to ensure its correct location.
