Tech Tip

BULLETIN TT003-13

ALL CHAIN DRIVEN WATER PUMPS

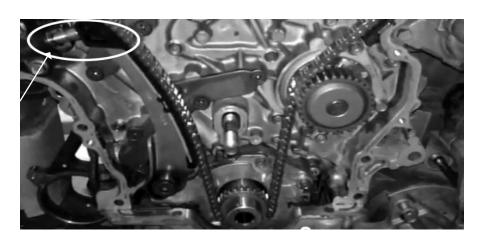
Correct alignment of tensioner and chain guide.

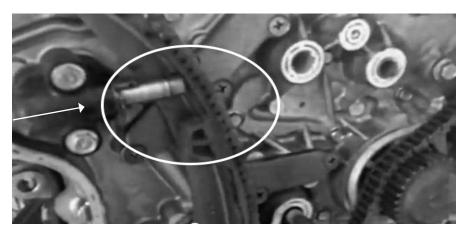
Incorrect alignment of tensioner and chain quide.

Water pump has missing or broken teeth, or sprocket falls off the shaft.

Misalignment or damage of the tensioner, guide or chain.

Visual inspection is required to verify the correct alignment of chain tensioner and guide. Inspect for broken, cracked or missing guide material as well. It is not advised to re-use misaligned components. Also, check the chain for any imperfections.

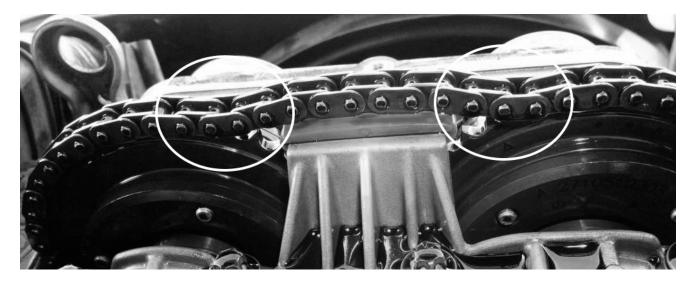
If the chain looks like the above circled areas, it is time to replace the timing components. Notice how the chain sags, this should not occur in any location of the chain drive. If slack is present replace the chain, chain tensioner, and chain guides.

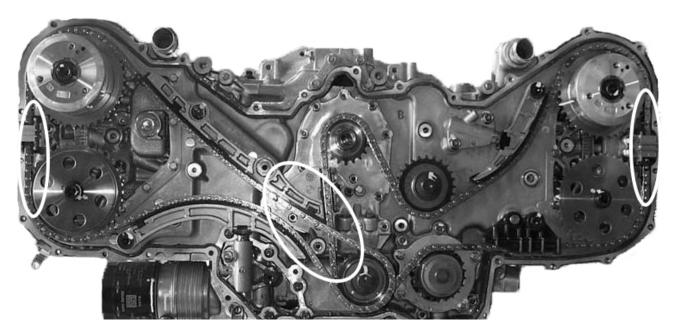
In the circles above there is no slack present. This is the optimal position for the chain.
