041

Technical Bulletin

DriveAlign® Tensioner T38192

T38192/K046PK1660

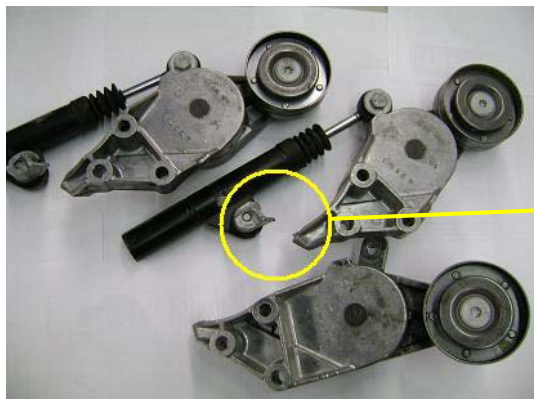
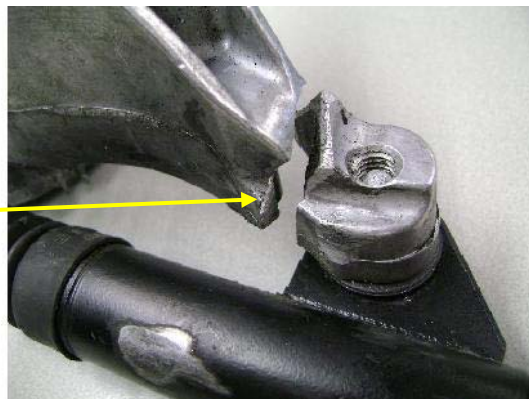
Different failures of this tensioner have led to garage visits where the reason of the early failures of this tensioner were investigated. During the examinations, the malfunction of the OAP was proven. The OAP not working properly anymore leads to abnormal belt vibrations, causing the tensioner bracket to be affected by material fatigue; leading to rupture (Fig. 1 and 2).

The bracket will always shear at the same point (just above the connection of the bracket with the hydraulic damper).

The broken tensioner bracket is the result of excessive vibrations, not the cause!

- Worn Overrunning Alternator Pulley
- Solid pulley installed instead of an OAP
- Using an OWC (One Way Clutch) instead of an OAD (Overrunning Alternator Decoupler)

The OAP is a wear item, which has to be regularly checked for proper function.

Replace the alternator pulley with the prescribed Gates part.

Follow OE recommended installation procedure.

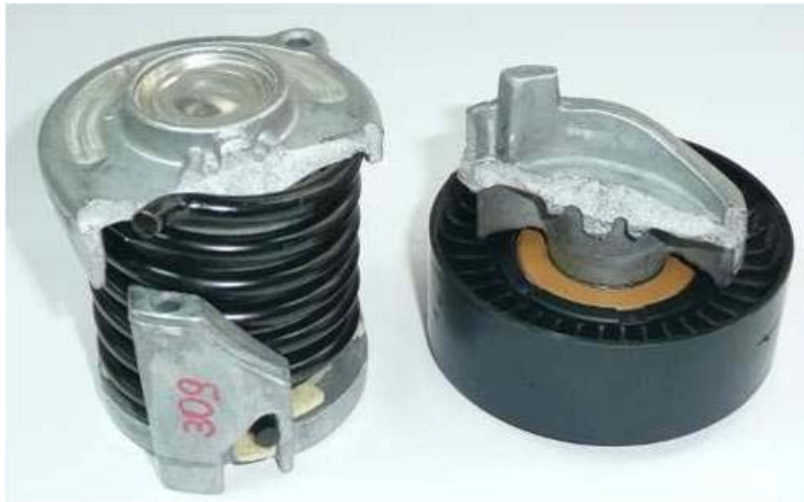
Fig. 3

Also in other cases worn/blocked OAP's have led to the failure of the tensioner (Fig. 3).
