027

Technical Bulletin

FORD 1.8 Diesel engine.

GATES REFERENCE :	5541XS/K015541XS
MAKE :	FORD / MAZDA
MODEL :	C-Max, Courier, Fiesta, Focus, Galaxy, Mondeo, S-Max, Tourneo Connect, Transit Connect
ENGINE :	121
ENGINE CODE :	1.8 Diesel (all 8 valves) Various

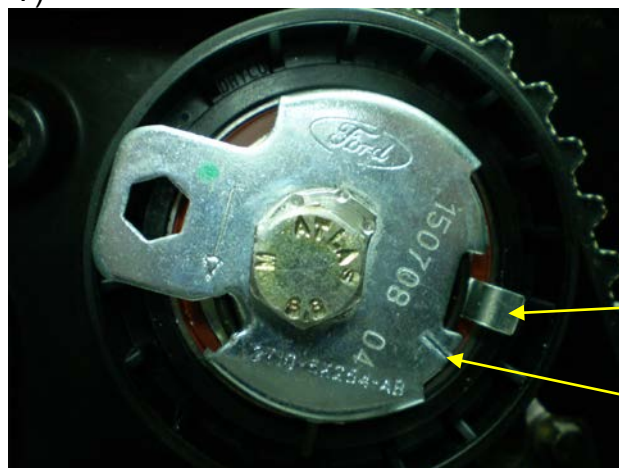
Fig. 1

Indicator in middle of the slot. ✓

Mark on the tensioner

- 1) Engine must be cold: the engine temperature significantly influences the installation parameters
- 2) Engine must be at TDC. All engine specific setting/locking tools can be found in Gates tool kit GAT4830
- 3) The crankshaft has to be blocked (when equipped with air conditioning, the alternator shaft has to be removed, 6 bolts to loosen).
- 4) The camshaft has to be blocked (at the back of the engine)
- 5) Camshaft sprocket bolt has to be loosened. Make sure sprocket is free to rotate on the taper, by using the sprocket remover in tool kit GAT4830 (if not done so, the belt will not be tensioned in the top span)
- 6) The tensioner must be turned anticlockwise, until the indicator is in **the middle of the slot (not lined up with the mark on the tensioner)** (Fig. 1)
- 7)

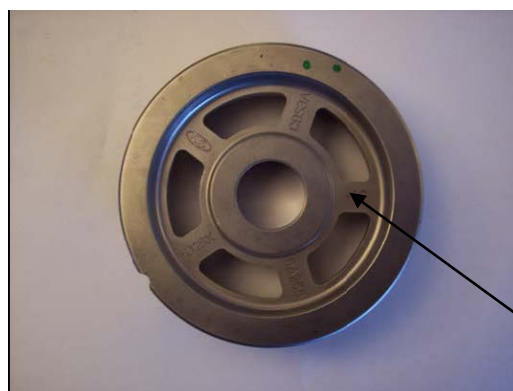
Fig. 4

Extension AC

Check if the part number of the camshaft pulley ends with **AC** (Fig. 4). Should the part number of the camshaft pulley end with **AB**, fit new sprocket with OE ref. XS4Q6A256**AC**.

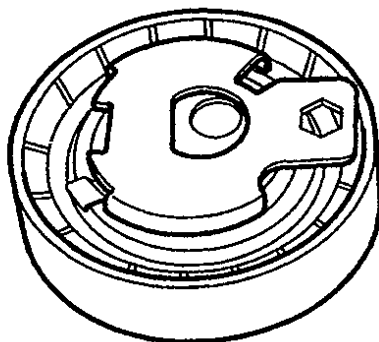
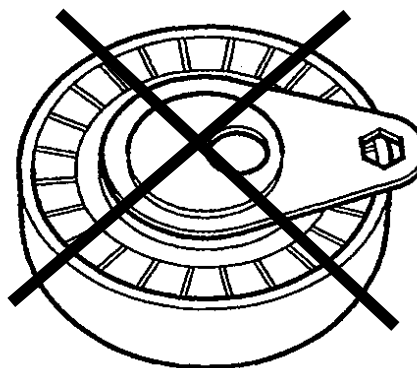
New automatic tensioner

Old manual tensioner

Fig. 5 shows the initial manual tensioner on the right side and the current automatic tensioner on the left.
