Timing belt/kit installation on GM (Isuzu) 1.7D engines

GATES REFERENCE:5563XS/K015563XS/K025563XS/K035563XSMAKE:CHEVROLET, OPEL, VAUXHALLMODEL:Astra, Combo, Corsa, Meriva, Tour, ZafiraENGINE:Isuzu 1.7 DTIENGINE CODE:A17DT, A17DTR, Y17DT, Y17DTH,
Y17DTL, Z17DTH, Z17DTH, Z17DTR

Questions and returns out of the field teach us there are still a lot of doubts on the contents/installation of this belt/kit, so we believe it is useful to launch a new bulletin on this engine. This replaces Technical Bulletin N° 009.

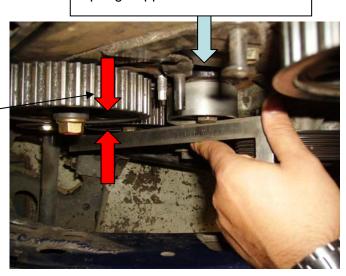
Fig. 6

4) Install new coil spring tensioner (spring over stud, bolt hand tight); make sure tensioner is sitting perfectly against engine block. If not, the spring could end up between the tensioner and the engine block, creating a serious tensioner misalignment (see Fig. 6)

Spring trapped behind tensioner

Serious

misalignment
