# 001

# Technical Bulletin

## Installation recommendations for timing system on GM 1.4, 1.6, 1.8, 2.0, 2.2 16V engines

<b>GATES REFERENCE :</b>	<b>5368XS, 5369XS, 5408XS, 5461XS, 5499XS, 5542XS</b>

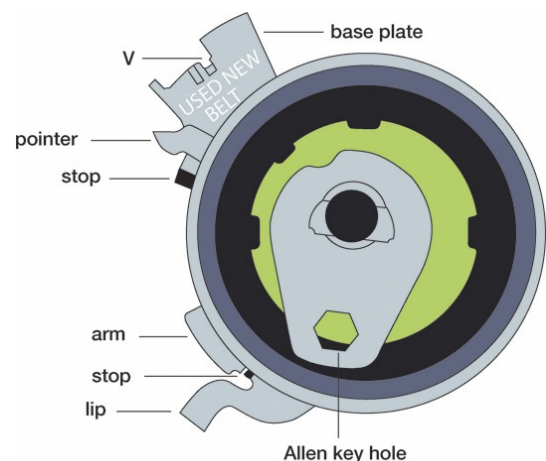
Fig. 1

- Align Top Dead Centre (TDC) marks. As the same engine used in a different model can have a different belt, we give the TDC marks following belt number here, and not following engine code.  
5369XS/5499XS: crankshaft: 5 O'clock, L-cam: 3 O'clock, R-cam: 9 O'clock  
5368XS/5408XS/5461XS/5542XS: crankshaft: 6 O'clock, camshafts 12 O'clock.
- Block camshafts
- Loosen tensioner bolt
- Turn tensioner clockwise and remove belt
- Remove old tensioner
- Install new tensioner, hand tighten bolt. Tensioner lip **has to be** in oil pump housing slot. (Tensioner pointer has to sit behind water pump pulley). The Allen key hole has **to be set** in +/- 7 O'clock position (fig. 1).
- Install new belt anti-clockwise starting at crankshaft

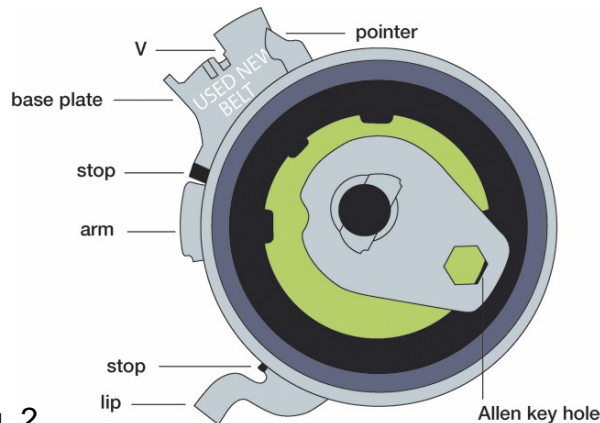
Fig. 2

- Turn tensioner (with Allen key) anti-clockwise (while holding the bolt in place) till pointer is in line with (not passing) right hand side of base plate (fig. 2)

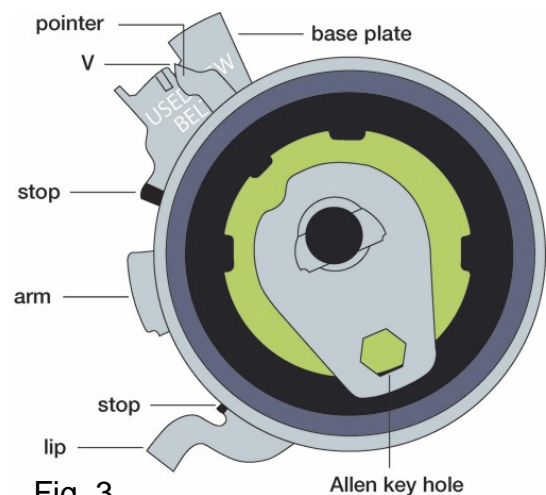
Fig. 3

- Adjust tensioner (while holding the tensioner bolt in place), till pointer in line with V ("NEW" position); the Allen key hole has to be in +/- 5 O'clock position now (fig. 3)

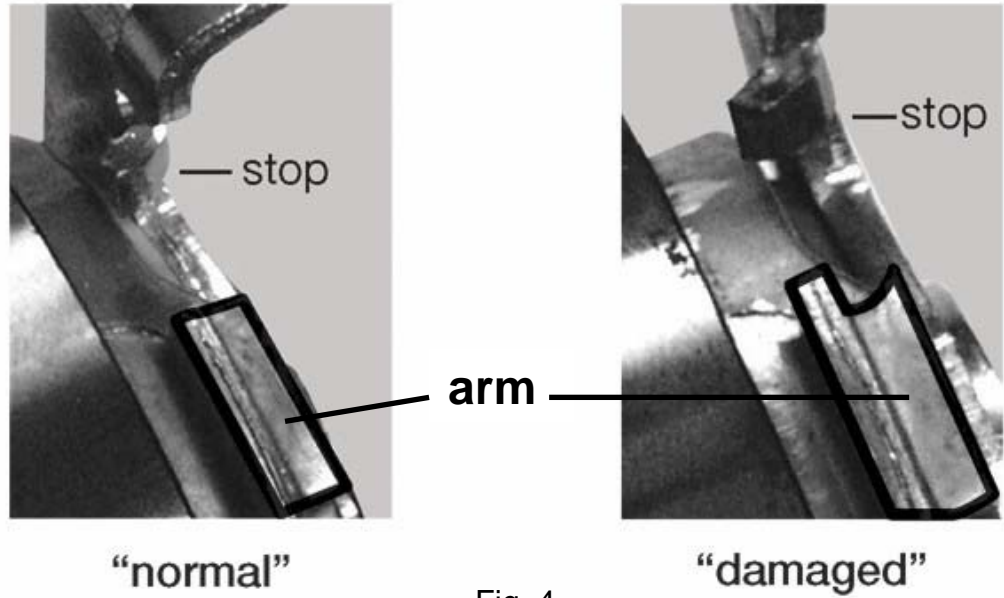
Fig. 4

Rotating the tensioner in the wrong direction, having the Allen keyhole in a wrong position to start off, not turning the engine 2 revolutions before and after setting the tension, can lead to system failure. This will cause the arm of the tensioner to hit the stop, creating a hammering noise, damaging and possibly even rupturing that part. This failure mode is very common and can easily be recognised when inspecting the edge of the arm (fig. 4). The resulting wrong tension can cause the belt to rupture.
