# 012

# Technical Bulletin

## Installation of tensioner used in PowerGrip® Kits K015543XS, K025543XS and K015559XS

<b>GATES REFERENCE :</b>	<b>K015543XS, K025543XS and K015559XS</b>
<b>MAKE :</b>	AUDI / SEAT / SKODA / VOLKSWAGEN
<b>MODEL :</b>	A3, Cordoba, Ibiza, Inca, Leon, Toledo, Octavia, Bora, Caddy, Golf, New Beetle, Polo
<b>MOTOR :</b>	1.9 SDi / TDi
<b>MOTOR CODE :</b>	AGP, AGR, AHF, ALH, AQM, ASV, ASY, AYQ

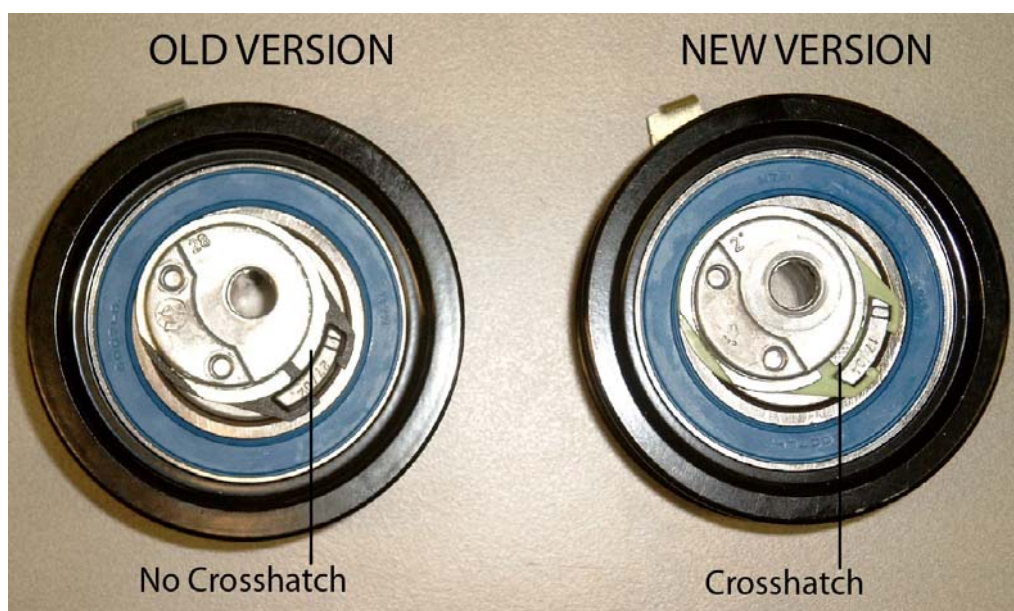
In Fig. 1 you can see that only the new version has a crosshatch belt wear indicator (see also Fig. 4). This section indicates when the timing belt is worn out and when it needs replacement.

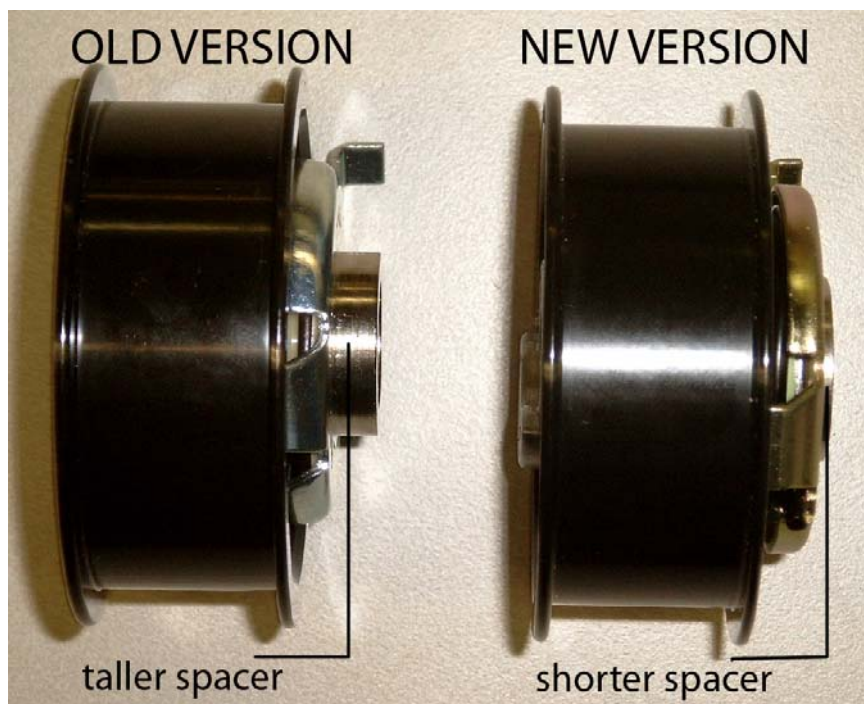
In Fig. 2 you can see that the new tensioner also has a shorter spacer. However, the distance between the engine block and the pulley remains the same.

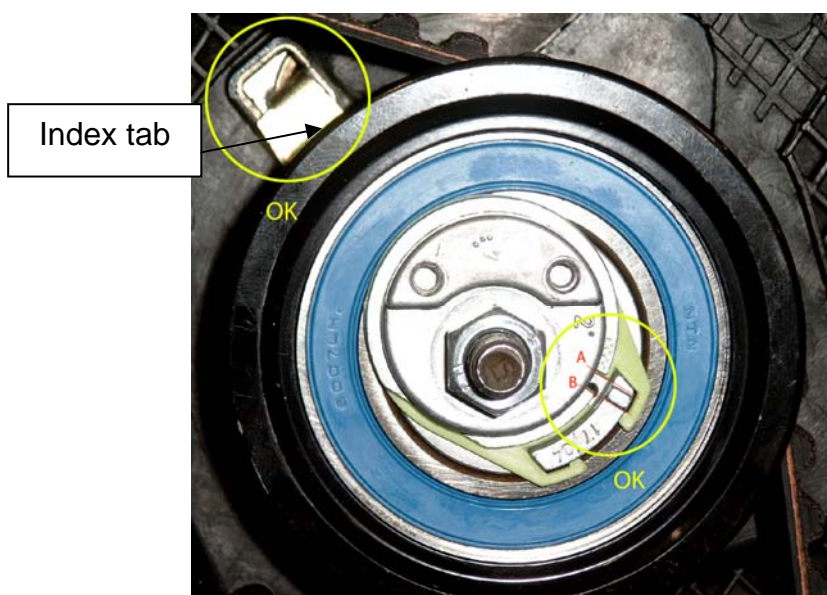
Fig. 3

When after two engine revolutions the pointer is between lines A and B and the index tab is **in** the slot and pushing against the **right hand** side (Fig. 3 and Fig. 4), only then the tensioner is perfectly positioned.

When the new tensioner is installed, verify that the index tab is located and properly seated in the slot (Fig. 3 and Fig. 4). Use the special tool to tension the tensioner and turn clockwise until the pointer lines up perfectly in the window, between the lines A and B. You can use a mirror to properly see this in the engine compartment. Now tighten the bolt at 23Nm.

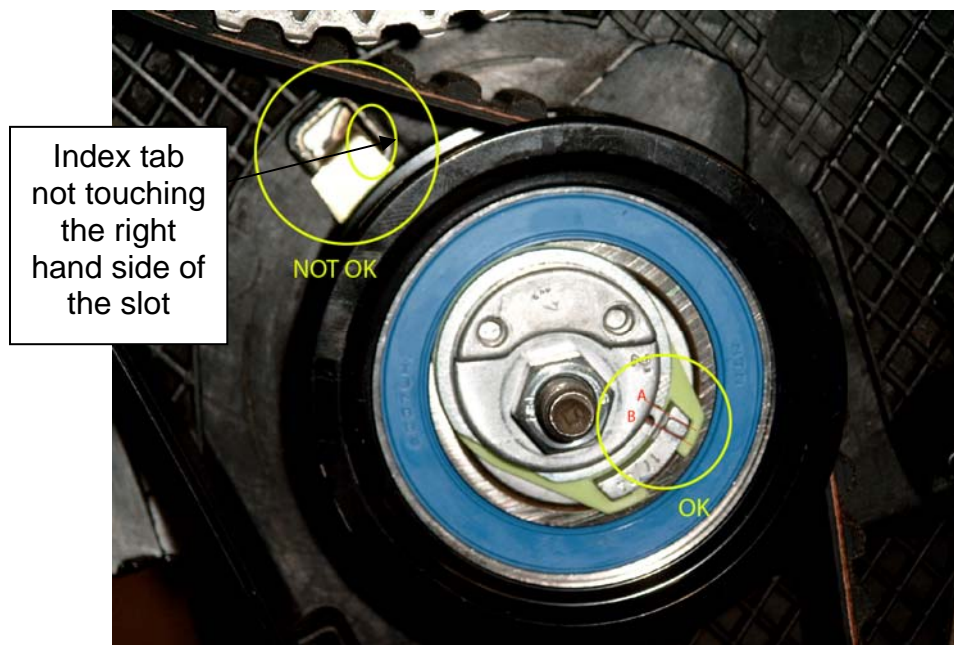
Fig. 5 shows one of the common errors. Pointer is perfectly positioned between lines A and B but the index tab is not OK. The index tab is in the slot but is not pushing against the right hand side of the slot. The reason for this is that the tensioner was moved anti-clockwise during the tensioning process.

If the pointer is not well positioned, the mechanic should restart the tension-setting procedure completely.

**When you are in the tension-setting, never turn the tensioner anti-clockwise!**

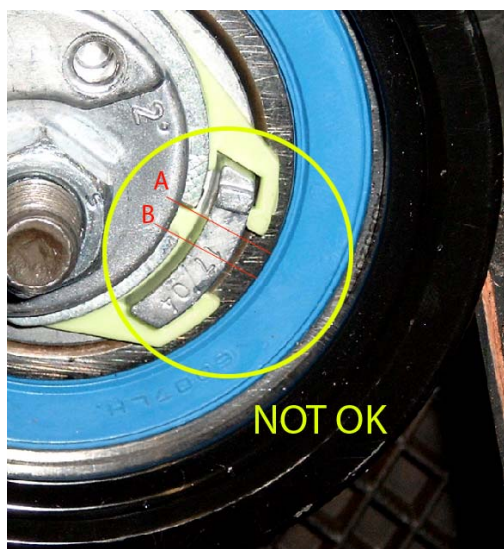
Fig. 6

A second possible error can be seen in Fig. 6. You can see that the pointer has not passed line A and is in front of the crosshatch. This means that the belt will have a too low tension.

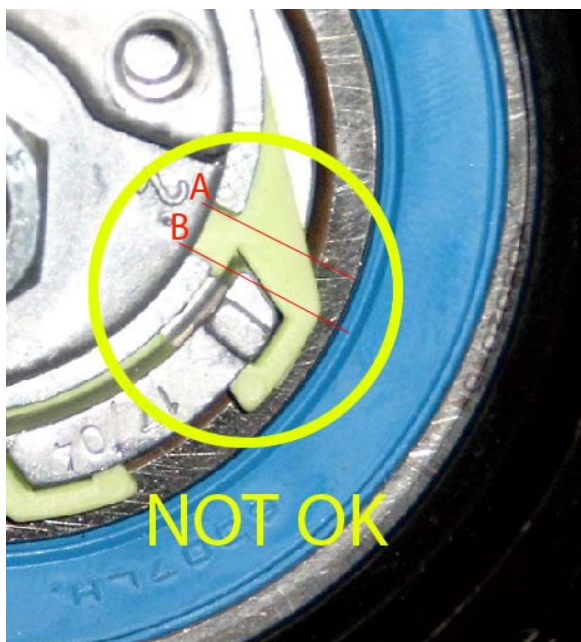
Fig. 7

A third installation error is shown in Fig. 7. The pointer has passed line B, this means that the belt will be tensioned too much.

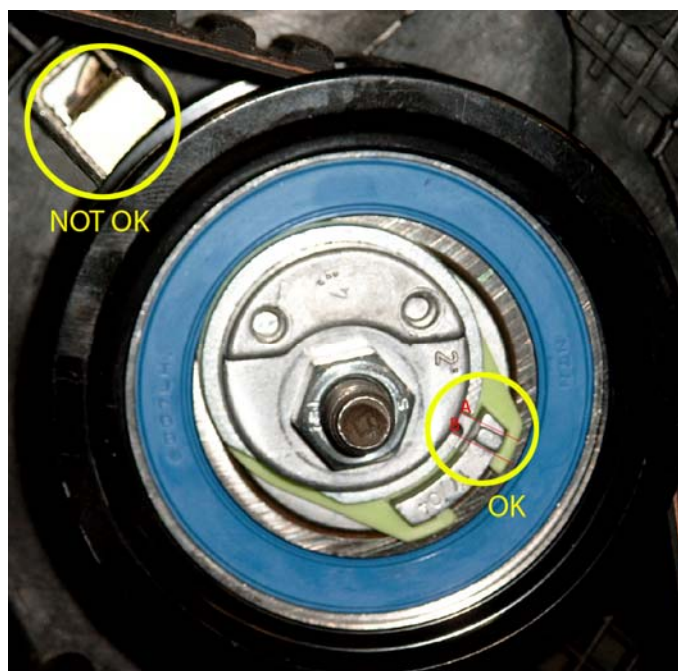
In Fig. 8 you can see a fourth error where the index tab is not locked in the slot although the pointer is perfectly positioned between lines A and B. This way the belt will lose its tension once in operation.

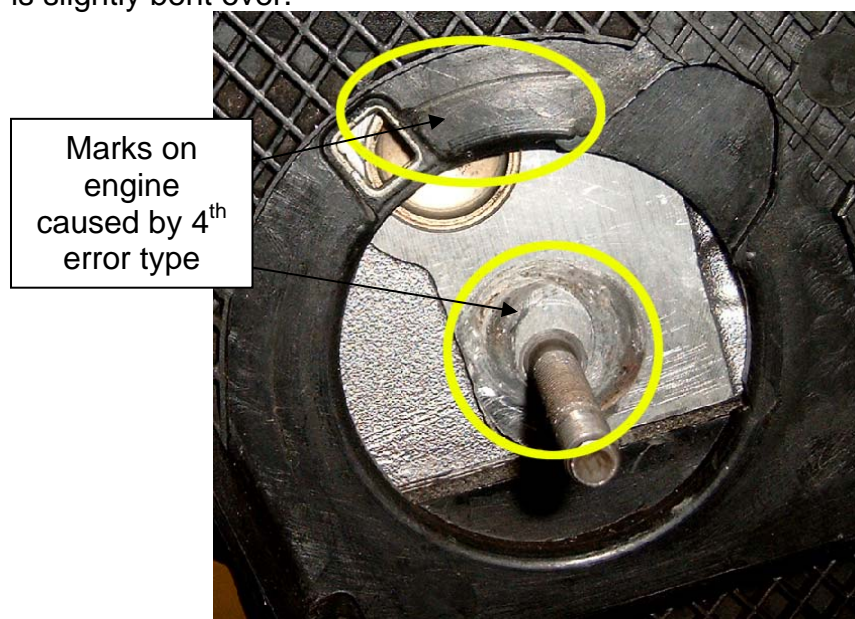
Fig. 9

You can see the marks on the engine caused by this type of wrong fitment in Fig. 9. In this case you will also see that the index tab on the tensioner is slightly bent over.

**When the vehicle is released with a wrong positioned tensioner, severe engine damage will happen sooner or later.**

We can not stress enough how important it is to follow all the steps in the process of installing this tensioner without skipping one of them. It is better to lose 5 minutes at the installation then to lose an entire engine in the end.
