Technical Service Bulletin

AUTOMOTIVE <> PASSENGER CAR SYNCHRONOUS BELT DRIVE SYSTEM

BULLETIN PA008-11

REAR CAM ALIGNMENT

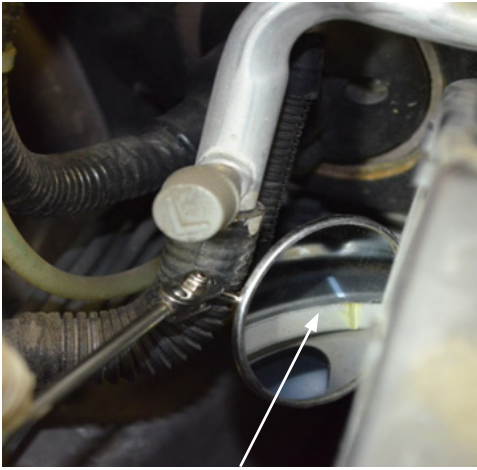
The most common cause found with immediate illumination of the MIL associated to cam sensor codes has been misalignment between the rear cam gear and timing belt. Illumination of the MIL will occur with the cam being one tooth advanced or retarded.

Rear Cam Alignment With Mirror For Verification Highly Recommended

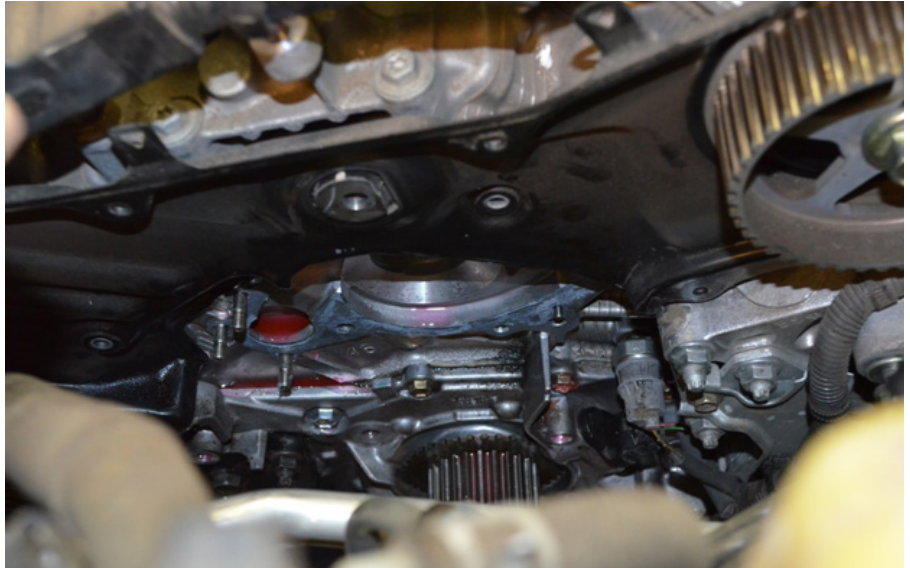
Gates always recommends replacement of the water pump assembly combined with a complete flush of the cooling system when performing timing system maintenance. Removal of the upper rear cam gear cover is unnecessary in order to R&R the water pump unless cam seal renewal is also being performed.

NOTE: Do not interchange or mix cam gear if they are removed – ensure they are kept in appropriate order. [right vs. left and front vs. rear]

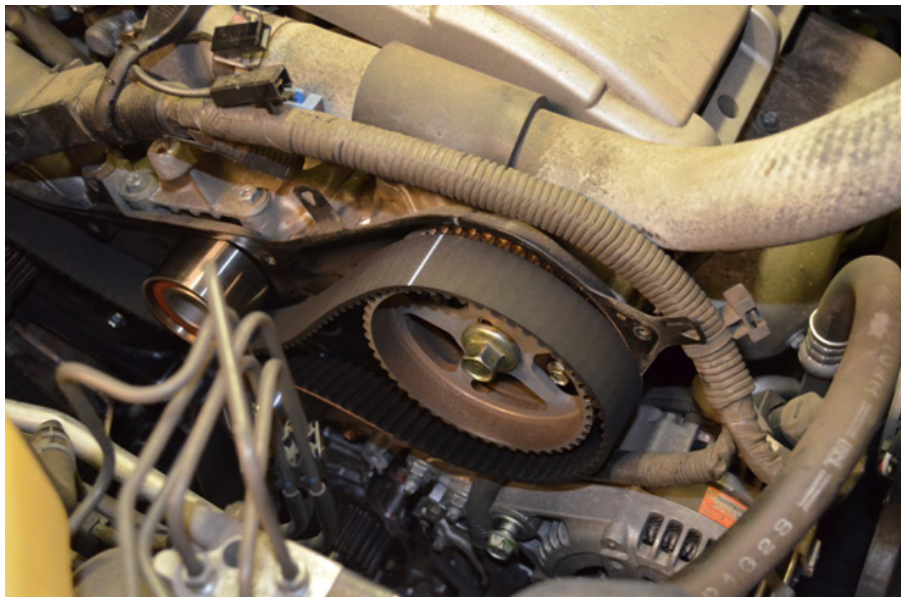
Cautions on related system components would include verification of the upper idler pulley operation. Due to the step design within the pulley, it is possible to secure this component at an improper angle. Ensure the idler pulley is operating within the same system plane and that the timing belt is tracking in the center of the bearing.
