Renault 1.4 & 1.6 16V / Synchronous Drive / Installation Info.

<b>GATES REFERENCE:</b>	<b>5501XS, 5671XS &amp; related kits.</b>

<b>MAKE:</b>	DACIA / LADA / NISSAN / RENAULT.	
<b>MODEL:</b>	Clio, Duster, Fluence, Kangoo, Kubistar, Laguna, Largus, Logan, Megane, Modus, Sandero, Scenic, Symbol, Thalia, Twingo, Wind	
<b>MOTOR:</b> <b>MOTOR CODE:</b>	Petrol 1.4 16V, 1.6 16V. K4J/K4M.

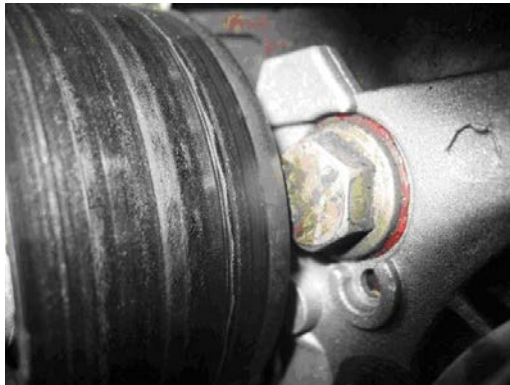
Fig.2

Fig. 2 shows the little space between water pump bolt and tensioner pulley.

We always recommend servicing with a complete water pump kit. While changing the water pump, make sure the correct bolts/washers are used and torqued correctly.

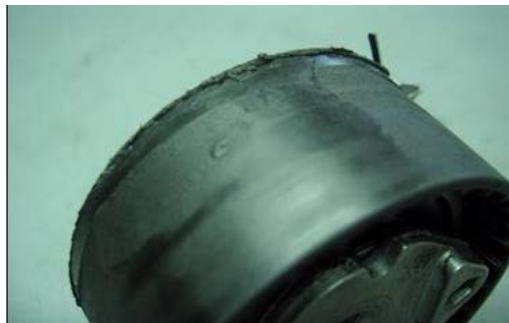
Fig. 3

Incorrect part or bolt coming loose leads to tensioner pulley contact (Fig. 3).

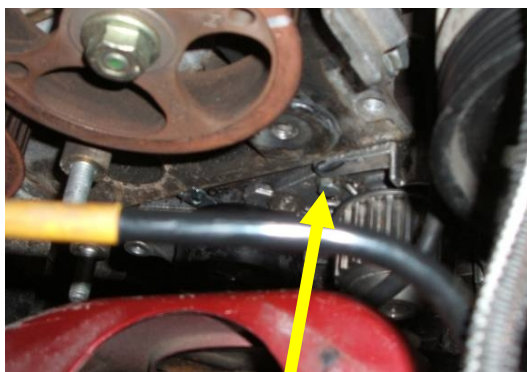
Fig. 4

While installing the new idler pulley, ensure that the spacer (sitting between the old pulley and the engine block) is re-fitted between the new pulley and the engine block. If not, the idler pulley can touch the water pump, causing idler and belt failure (Fig. 4 and 5).

Rubbing mark

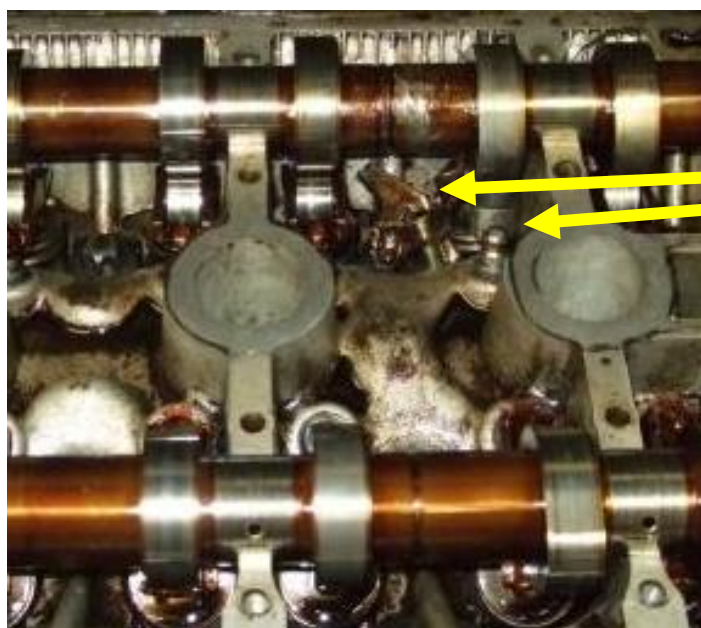
Fig. 7

In the event of an engine repair, after piston to valve contact, a close inspection of the camshaft rockers is essential. It is possible that rockers sustained damage. If so, the rockers must be replaced. Neglecting their replacement causes seizing of the camshaft. (Fig. 7)

Rocker broken
