Technical Service Bulletin

AUTOMOTIVE <> PASSENGER CAR ACCESSORY BELT DRIVE SYSTEM

BULLETIN PA002-14

ROOT CAUSE FAILURE OF BROKEN 38192 TENSIONER

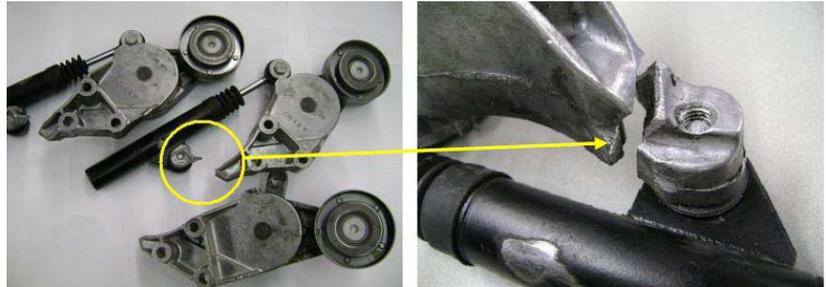
On models equipped with the Gates 38192 Tensioner assembly, it is possible that excessive tensioner movement or a broken tensioner assembly may be observed as illustrated below.

This type of failure is the result of severe vibrations in the accessory belt drive system. While a broken tensioner is the result, the root cause often lies elsewhere in the system. These vehicles came from the factory with an Overrunning Alternator Decoupler Pulley. OAD Pulleys are engineered to reduce noise, vibration, and harshness in the accessory belt drive system while reducing belt tension. A reduction in belt tension will lead to an increased lifecycle of the accessories and improved gas mileage. However, OAD Pulleys are wear items and will eventually fail. If left unchecked, a failed OAD Pulley will result in excessive and abnormal vibrations in the belt drive system, which may eventually lead to the catastrophic tensioner failure pictured above.

Another often overlooked cause of the broken tensioner seen above is the result of incorrect servicing of the OAD Pulley. If an OAD Pulley has been mistakenly replaced with a One Way Clutch Pulley or a Solid Pulley, the belt tensioner is forced to absorb excessive and irregular vibrations that otherwise would not exist.

Ultimately, both of these scenarios will result in the hydraulic strut attempting to compensate for the additional vibrations in the belt drive system. Unfortunately, the tensioner is not designed to withstand these conditions, and may eventually break as pictured above. Gates recommends replacing the ADP whenever the 38192 tensioner is replaced.
