SOFIM 2.4 / 2.5 / 2.8 Diesel engines

GATES REFERENCE :	5039 (K01), 5113 (K01), 5334XS (K01), 5335XS (K01), 5495XS (K01)
MAKE :	Fiat / Iveco / Opel / PSA / Renault
MODEL :	Various
ENGINE :	2.4 / 2.5 / 2.8 / D, TD, DTi, DTic, Dci, JTD, HDi (all 8 valves)
ENGINE CODE :	Various

026

Technical Bulletin

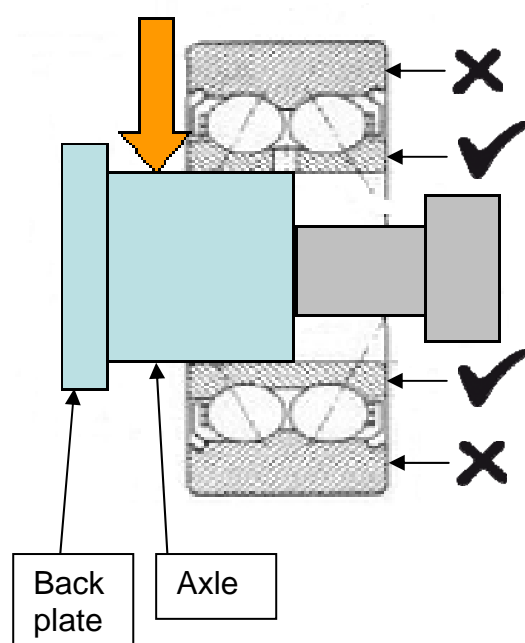
This would lead to misalignment of the bearing and its ultimate destruction. It also could lead to the seal coming loose, leading to loss of grease, and dirt coming into the bearing.

- Always remove rust or remaining grease from the axle/back plate before assembly (orange arrow). If you fail to do this, you will push all the dirt to the bottom of the back plate and you create a build up of debris, which will damage the bearing, due to misalignment or create a false tightening torque.
- Always install the bearing by pushing on the centre part of the bearing (✓)
- Never force the idler over the axle by pushing on the outside of the bearing (✗). See Fig. 1 and 2

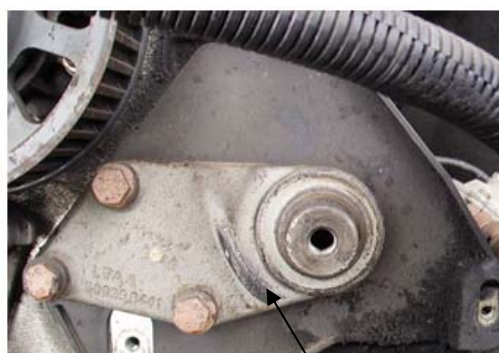
Fig. 3

Misalignment will also lead to the belt coming in contact with the back plate. This will leave a rubbing mark on the back plate (Fig. 3).

Rubbing mark

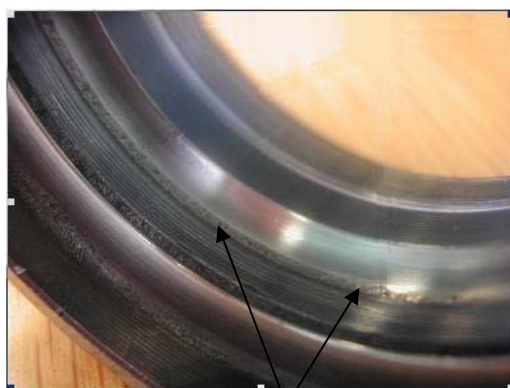
Fig.4

Figure 4: Bearing balls rolling outside their track due to misalignment and incorrect torque setting

Ball traces

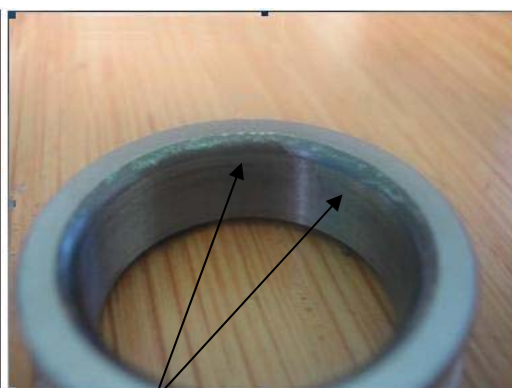
Fig.5

Figure 5: Abnormal rotation of the interior rings through incorrect tightening.

Abnormal rotation traces

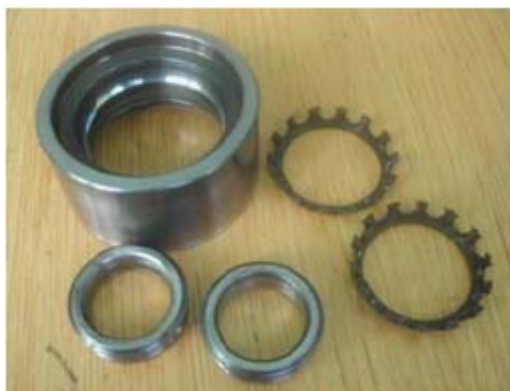
Fig. 6

Figure 6: Too low tightening torque will lead to the bearing falling apart.
Figure 7: Deformation of the balls because of excessive temperature, resulting from too high tightening torque.

- Always check the play between the axle and the bearing. If there is excessive play, replace axle/back plate
- Always apply the OE recommended tightening torque; it is very important as it determines the preload of the bearing.
- Always use fixing glue in order to avoid the bolt/nut coming loose due to vibrations and thermal expansion/contraction of the different metal parts (if the bolt/nut loosens, the bearing falls apart) (See Fig. 6).

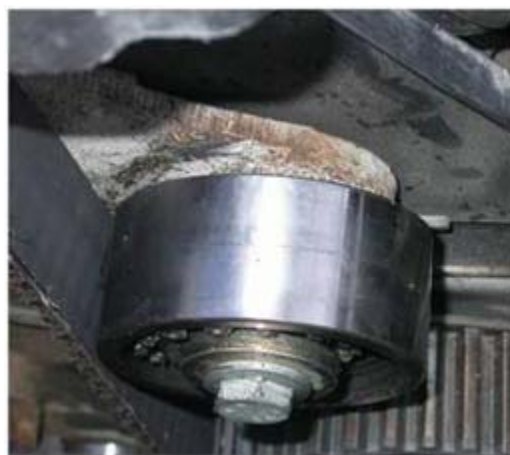
Fig. 8

Figure 8: Seal has come out of the bearing and ball cage has been destroyed.

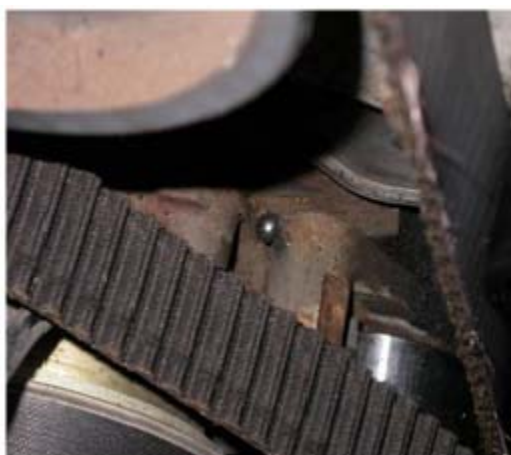
Fig. 9

Figure 9: One often can find balls in the lower engine compartment. Remove all debris from the drive system
