Technical Bulletin

Tension setting on Mitsubishi/Volvo 1.8 16V petrol engines

GATES REFERENCE :	5514XS/K015514XS

MAKE :	MITSUBISHI / VOLVO	
MODEL :	Carisma, Pajero IQ, Pajero Pinin, Shogun Pinin, Space Star, S40, V40	
ENGINE :	1.8 DOHC	
ENGINE CODE :	4G93, B4184SJ, B4184SM

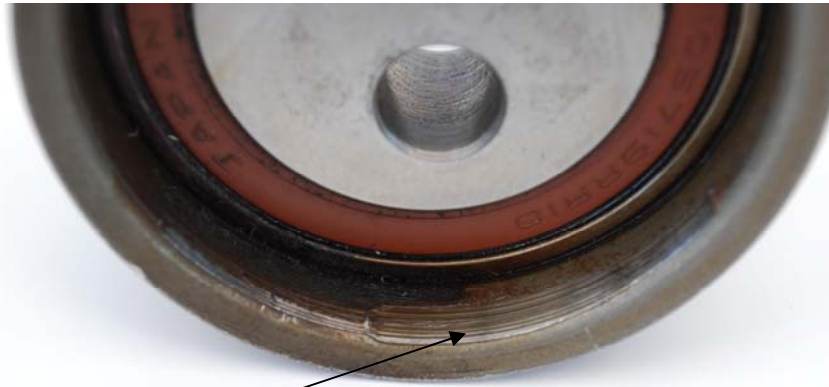
Fig. 3

Evidence of this can be found on the back inner side of the tensioner pulley. (Fig. 3)

Rubbing mark

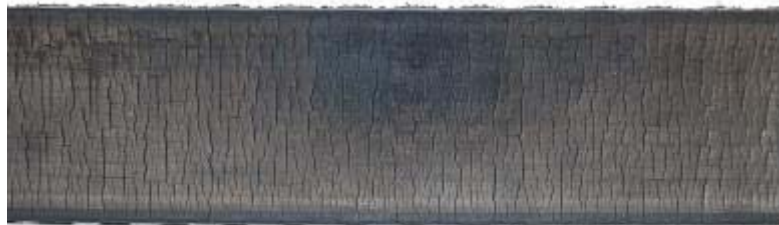
Fig. 4

Since the pulley cannot rotate anymore, the belt back - constantly rubbing against the pulley surface - will start to overheat and crack (Fig. 4).

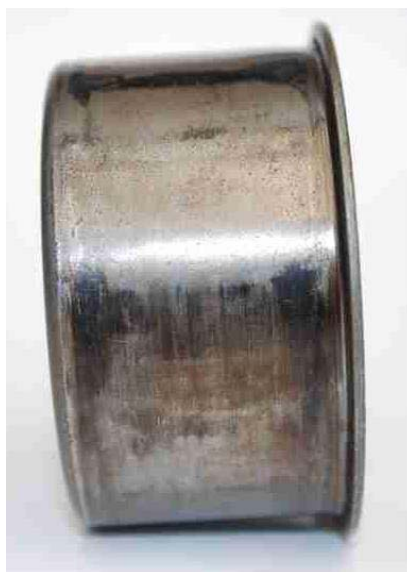
Fig. 5

This excessive temperature is further transmitted to the tensioner and idler pulleys, leaving a blue heat mark on the pulleys (Fig. 5), and possibly even traces of melted rubber (Fig. 6).

In general it is strongly recommended to replace the tensioner and idler pulleys together with the belt, as these parts obviously also wear out. A worn bearing (loss of grease, seizure, misalignment ...) is just as bad as a worn belt, and will lead to premature drive failure, resulting in serious engine damage.

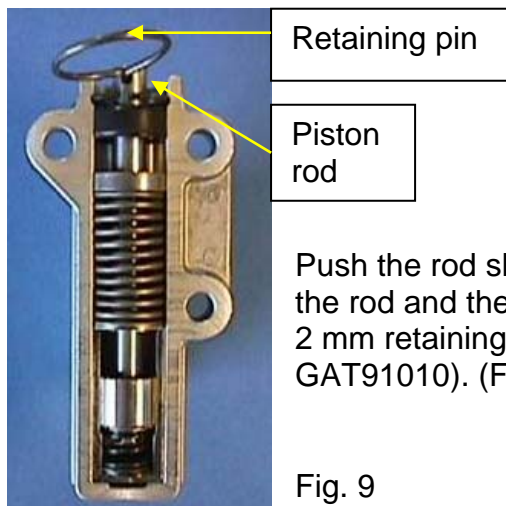
Fig. 9

By now, the piston rod of the hydraulic tensioner has come out of the tensioner body by 10.5 to 11.5 mm. If not, or leakage is present, replace the tensioner.

Apply a pressure of 10 to 20 Kg on this rod; movement of the rod should be maximum 1 mm. If more, replace the tensioner.

Push the rod slowly down (vertically) until the holes of the rod and the tensioner body are in line. Insert a 2 mm retaining pin (can be found in GAT4657 or GAT91010). (Fig. 9)
