045

Technical Bulletin

Tensioner/kit installation on PSA diesel engines

GATES REFERENCE : MAKE : MODEL : ENGINE : ENGINE CODE :	T41139, T41140 and kits K015523XS, KP15523XS, K015524XS, K025524XS, KP15524XS, KP25524XS, K015558XS, KP15558XS, K015588XS, KP15588XS, K015590XS. CITROEN, FIAT, LANCIA, PEUGEOT, SUZUKI, TOYOTA, Various 1.9 D, 2.0 D, 2.2 D Various

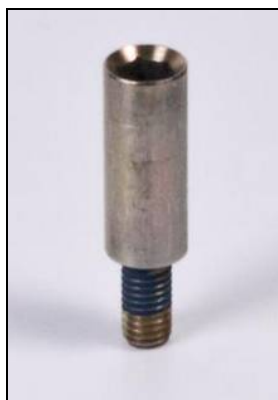
Fig. 1

We've found several cases where the tensioner pulley was not positioned correctly over the mounting stud (Fig. 1).

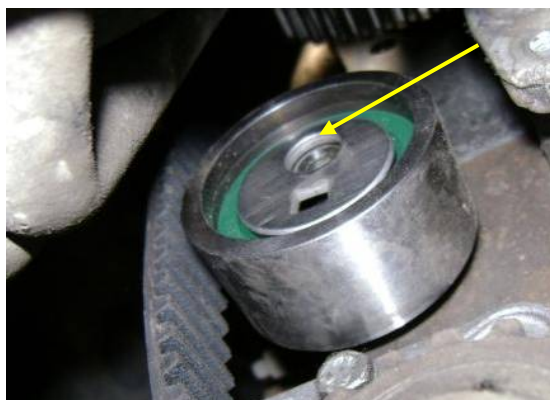
Fig. 2

If the inside of the tensioner front plate rests against the front edge of the mounting stud (Fig. 2 and 3), the result will be that the tensioner pulley is not sitting straight over the stud EVEN after the fixing bolt (Fig. 4) has been correctly torqued. This will lead to a belt misalignment, resulting in premature failure.

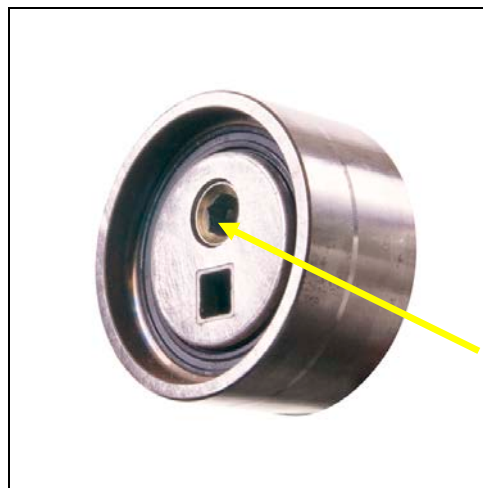
Fig. 5 shows a correct stud position.
