035

Technical Bulletin

Timing belt/kit installation on VAG 1.4/1.6 16V

GATES REFERENCE :	5565XS/K015565XS/K025565XS/KP15565XS/ KP25565XS-1/KP25565XS-2/T43149	
MAKE :	AUDI, SEAT, SKODA, VOLKSWAGEN	
MODEL :	Various	
ENGINE :	1.4 16V, 1.6 16V	
ENGINE CODE :	Various

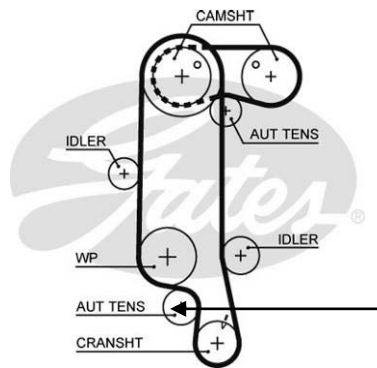
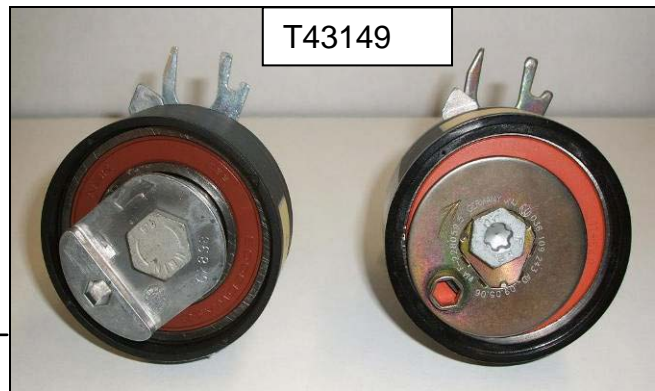
Fig. 1 shows the 2 different versions of automatic tensioner (for the main drive) which can be found in our kits. They are interchangeable.

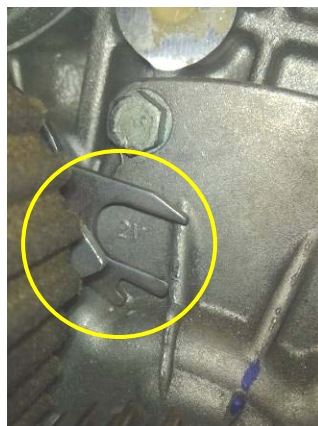
Fig. 2

It is clear an incorrect position of the locating lug (Fig. 2, 3 and 4) will lead to an incorrect belt tension or to the fact the belt cannot be tensioned.

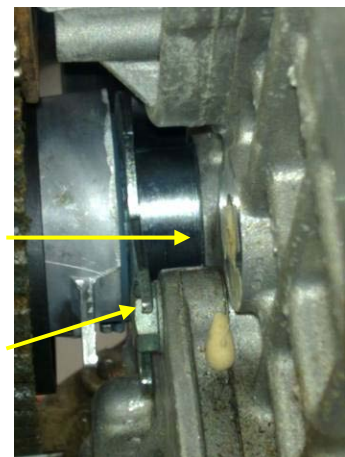
Fig. 10

No gap

Good position

Tighten tensioner bolt finger tight, assuring tensioner is in the correct position (Fig. 10).

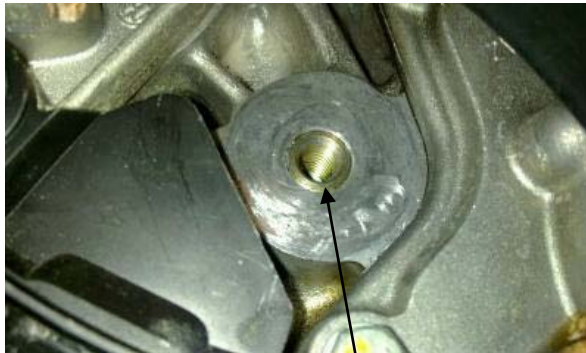
Fig. 11

- deformation of the tensioner leading to overheating of the bearing
- damage of the thread in the alloy engine block, leading to the need of a thread repair (Fig. 11)
- bolt rupture

Repaired thread

Make sure thread in engine block is still OK.

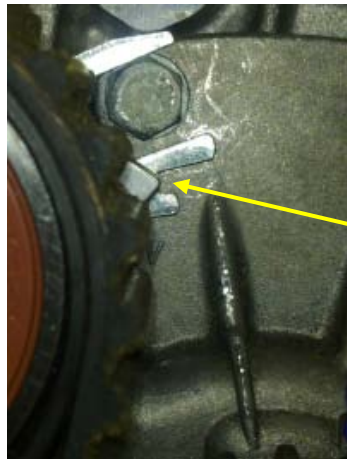
Fig. 15

Pointer in centre of the notch

Turn tensioner pulley in clockwise direction till pointer and base plate notch are well in line (Fig. 15).

Torque tensioner bolt (20 Nm)
Turn engine 2 revolutions to TDC and verify pointer position (adapt if needed).

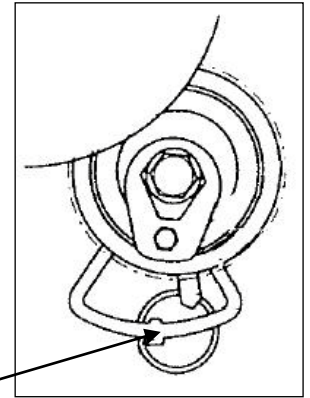
Fig. 17

Locating lug

- the locating lug is placed in the hole in the cylinder head at 6 o'clock (Fig. 17).
- the tensioner is turned anti-clockwise until the pointer is in line with the positioning lug
- the tensioner bolt is torqued to 20 Nm
- the engine is turned 2 revolutions to TDC and pointer position verified (adapt if needed).

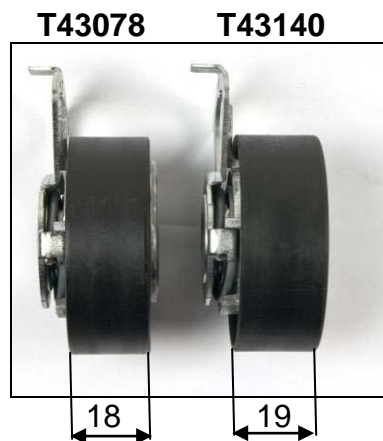
Fig. 20

The pulley width of the K01 tensioner (T43078) is 18 mm, for the K02 tensioner (T43140) this is 19 mm (Fig. 20).

They are NOT interchangeable.

Make sure you install the correct PowerGrip® Kit depending on engine number:
