Technical Bulletin

VAG 1.9, 2.0 TDI – Auxilliary drive.

T38306/5PK1435

Audi, Skoda, Volkswagen

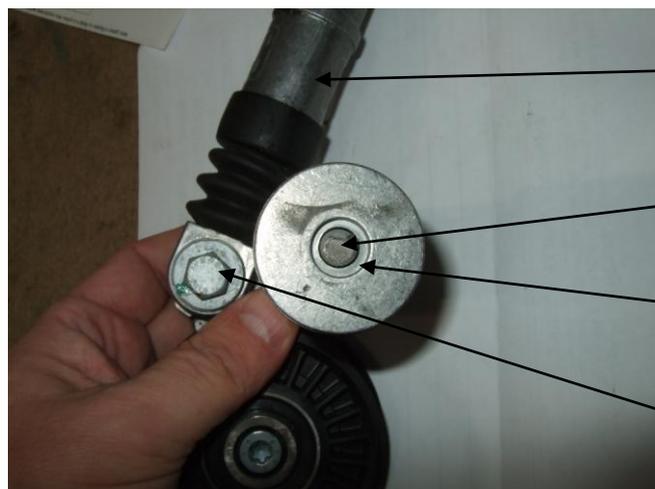
Fig. 5

Also the installation torque of the tensioner mounting bolts is critical. Failure to apply the correct torque will usually lead to the central mounting bolt shearing.

Hydraulic actuator

Broken bolt shaft

O-ring position

Possible excessive wear of the fixing hole

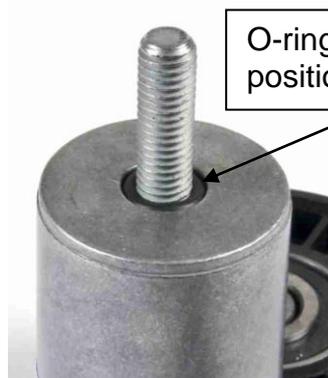
Fig. 6

O-ring in correct position

Bolts on this tensioner should be torqued to 25Nm. In order not to influence the torque of the central bolt, make sure that the o-ring is sitting correctly in its foreseen location. (Fig. 6)

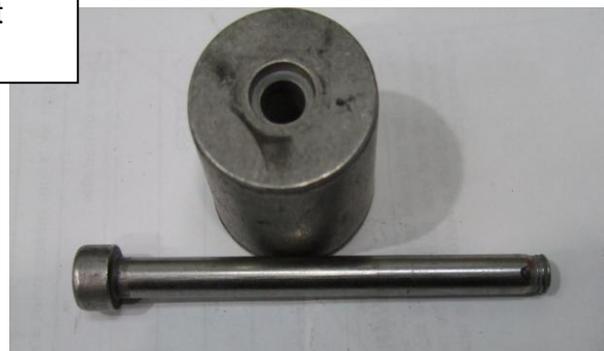
Fig. 7

If the mounting bolts are too tight it will distort the mounting bushing, preventing the hydraulic actuator to pivot on the mounting bolt. All forces are therefore transmitted to the central mounting bolt, which eventually shears.

A too low torque on the central bolt will lead to the load/vibrations being absorbed by the bolt shaft, also resulting in a bolt rupture (Fig. 7).

Also make sure the hole in the alternator bracket is free of rust, dirt and grease, as this again could influence the bolt torque.
