Tensioner problems

A VW Golf 16 Valve engine met a premature end when one of the timing belts broke. Gates Technical Support's Andrew Vaux takes us step-by-step, as he examines all of the evidence to determine why the belt failed.

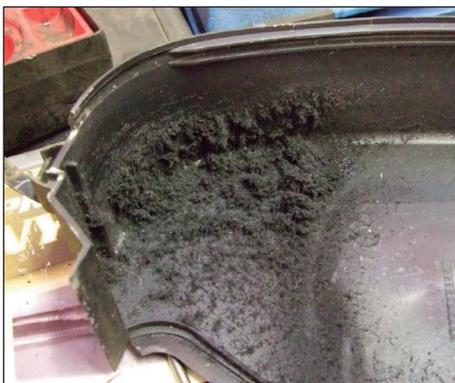
Debris from the worn belt was abundant inside the drive system cover

A likely cause of reduced width is regular contact with the engine block. This would be clear from a scoured or polished surface on either the drive system cover or the engine block. While no evidence of any such contact could be found, debris from the worn away belt was found inside the drive system cover.

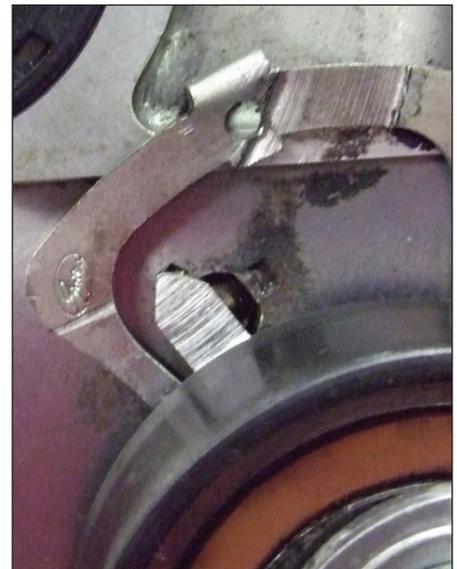
The mystery grew when careful examination of the backplate on the automatic tensioner revealed the kind of damage that had been sought. This would not normally be within the operating plane of the belt.

It was now clear that the reduction in width had been caused by contact with the belt tensioner and not the engine. This failure was a symptom of a very different problem.

When the Gates inspector placed the automatic tensioner in this position, contact with the belt was shown to be inevitable. The evidence supported the view that the automatic tensioner had been fitted incorrectly.

The upside down tensioner left no clearance room for the timing belt, as can be seen by the scoring in this picture

Installing a tensioner upside down is a basic error that any mechanic can make, regardless of the number of times the procedure may have been carried out on a particular model. It's always worth making a note of the position and aspect of a tensioner before it is removed.
