## *Alfa 156, all versions / Sun-Sensor*

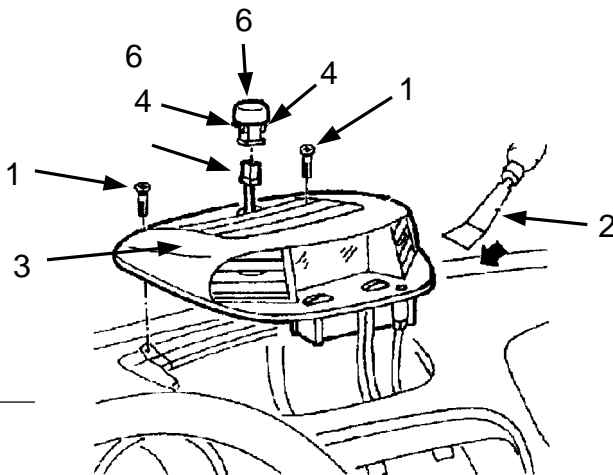
The speed of the interior fan suddenly change.

Through an abnormal function of the sun-sensor in contact with the A/C control, the speed of the interior fan can alternate.

This concerns vehicles, up to the identification number : 206065. In the case of a complaint, the cable of the sensor must be disconnected.

- Dismantle the mounting screws of the middle air cap (1).
- Dismantle the info- and air cap unit (3) with a wrench (2) from the retaining channel clamps. Thereafter pull out the unit from the dashboard.
- Dismantle the clamps (4) of the sun-sensor (5) and blame him following through the bore.
- Disconnect the electrical connection (6). The plug must be isolated and fastened so, that no noise occurs.
- Rebuild the sun-sensor.
- Rebuild the info- and air cap unit in reversed order again.
