Alfa Romeo 147

From model year 2001 All vehicles with petrol engine (except for GTA version)

Engine control lamp illuminates

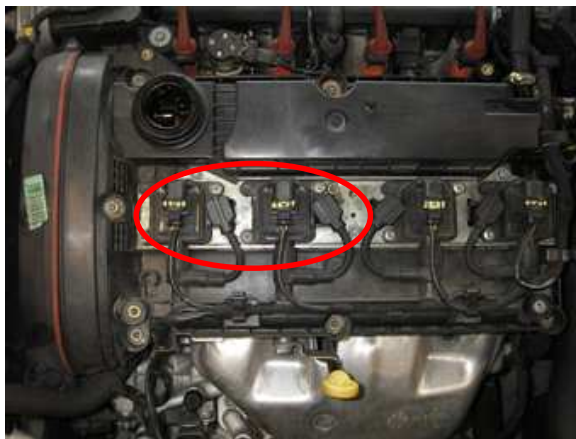
If there are complaints about the above-mentioned fault, the cause could be water in the ignition-coil shafts. Due to large amounts of splash water in the engine bay, e.g. after long periods of driving in rain or after driving through a large ford, it is possible that water may penetrate beneath the cylinder-head cover and run into the ignition-coil shafts of cylinders 1 and 2 (see photo.).

If the water rises up to the spark-plug connectors, arcing and, therefore, misfires occur. In this case, the spark-plug connectors and ignition coils must be removed and the shafts purged using compressed air.
