Alfa Romeo 156

ABS failure - Sensor water ingress

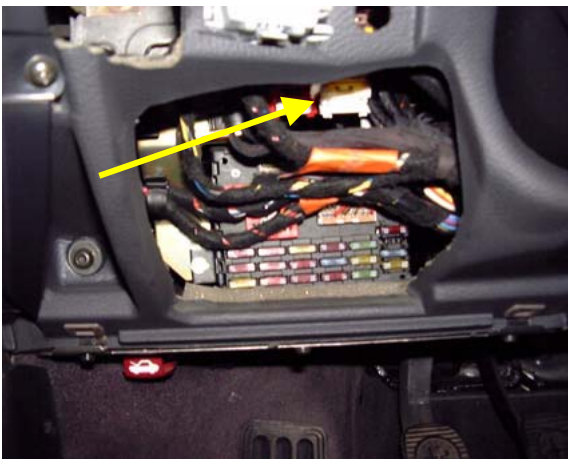
Picture 1: ABS-fuse:
below the instrument panel,
left next to the steering column (LHD)

If the anti-lock braking system should fail intermittently or completely on the above-mentioned vehicles, all plug connections of the ABS-sensors and electrical wiring must thoroughly be examined for ingressed humidity and oxidation. The failure cause has to be removed often by cleaning the connection points. Naturally the fuses for the anti-lock braking system should also be checked (picture 1+2).
