Alfa Romeo Mito starting year of construction 10/2008

Condensation forming on the front fog lamp

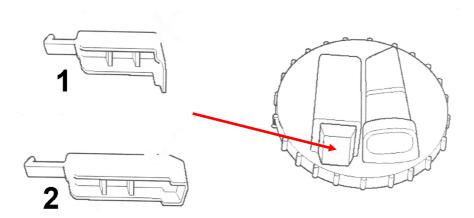
If complaints are made about the above issue, this does not necessarily point to any error. If the covering pane is covered by condensation, the area where light is emitted should dry within 20 minutes of driving with the low beams turned on. The time for this process can vary, however, due to the ambient temperature and relative humidity. This process is normal according to physical laws and harmless from a technical point of view. The exact physical processes are explained in the TI "Condensation on headlamps". This TI is also a very good aid for discussing the issue with customers. If the condensation becomes so heavy, however, that water drops form on the inside of the covering pane, the seals on the headlamp should be checked for damage. As a corrective action, dry and optionally clean the headlamp with oil-free compressed air. Remove the ventilation elements (see Fig. 1) from the fog lamp. Install optimized ventilation elements with part no. 71753060 in the headlamp (see Fig. 2).
