Audi A6 (4B) Model year 2003

Illumination of the headlight range adjustment control lamp in the cockpit

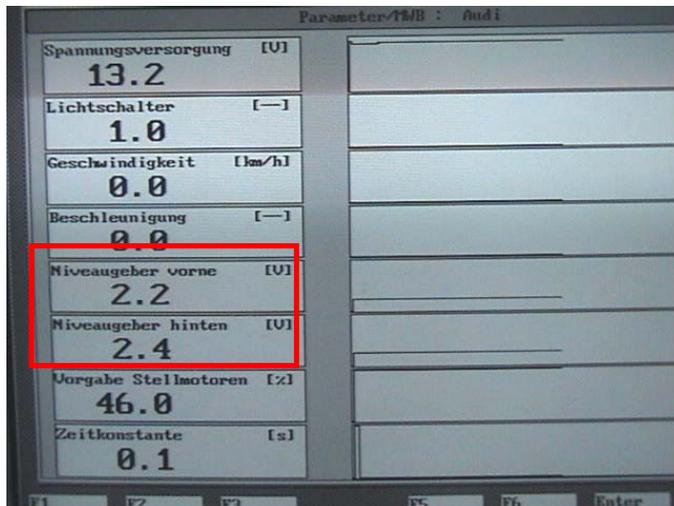
Fig. 1 ["Niveaugeber vorne" = "Level sensor front",
"Niveaugeber hinten" = "Level sensor rear"]

If there are complaints about the above-mentioned fault, the cause could be a defective headlight range adjustment control unit. In the case of vehicles with dynamic headlight range adjustment, fault 01535, "Triggering for servomotor for headlight range adjustment right-V49, short-circuit to earth", is also stored. In this case, the axle sensors and the cables to the control unit must be measured and/or checked for mechanical damage. The measurements can be carried out with most diagnostic testers e.g. under the menu item "Measured values/Parameters". There, the voltage values of the individual axle sensors can be checked (see Fig. 1). If, however, no faults are present, the headlight range adjustment control unit must be replaced.
