BULLETIN

Audi A6 (4F2/C6) Model year: 2005 - 2011 Engine: 2.0 TFSI

Interior blower not working Error in data bus communication

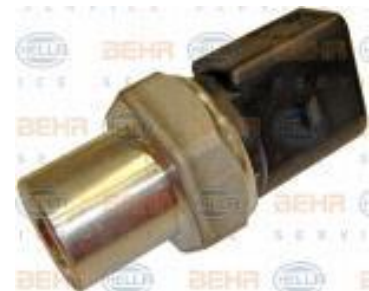
If the interior blower fails on the vehicles mentioned above, the cause may be a faulty pressure sensor in the air-conditioning system.

The blower output stage and the pressure sensor (see figure) use a shared signal line to communicate with the control units (Climatronic). If the sensor fails, communication is disrupted and the blower is no longer activated. The error code 2071 is then stored in the error memory.

If the blower fails, diagnostics should be carried out as follows:

- Check fuses
- Read out the error memory
- Check the parameter for the pressure sensor via the measured value blocks (the parameter should be around 5 bar when the air-conditioning system is filled and switched off)
- Check the control of the sensor and fan as necessary
