Audi A6 (B4) Model year 2003

Water entry into the passenger footwell

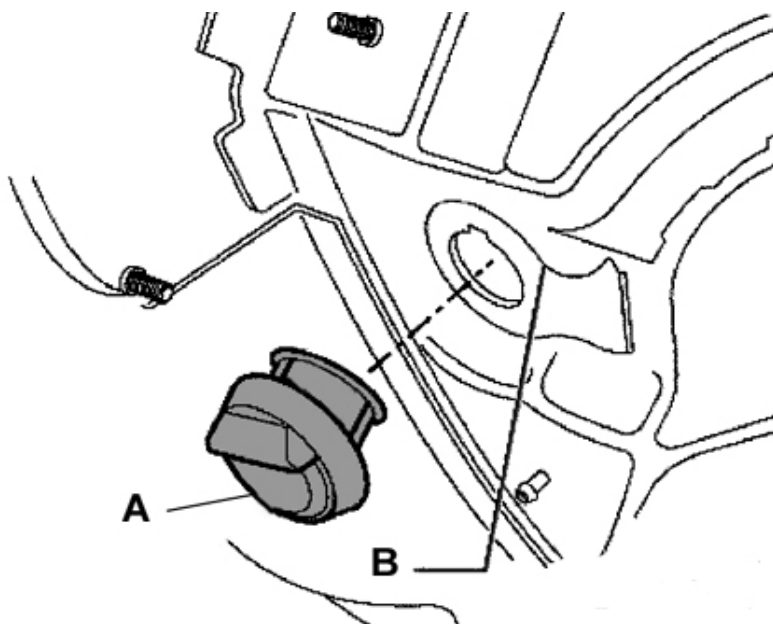
Fig. 1

If there are complaints about the above-mentioned fault, a defective rubber valve or an incorrectly seated wind deflection plate could be the causes.

In the first case, the valve (see Fig. 1, Item A) of the condensed water drain is covered, and therefore water can no longer drain. The condensed water in the air conditioning housing rises until it runs over the footwell air vent in the passenger footwell.

1. Install a new, improved drain valve in the floor panel. When fitting, ensure that the valve is seated correctly in the floor panel (see Fig. 1, Item B).
2. Scratch the mounting clip with a sharp knife and remove it. The clip is used in production only for fitting the screen and otherwise has no further function. When fitting the wind deflection plate, ensure that it lies absolutely tight on the windscreen.

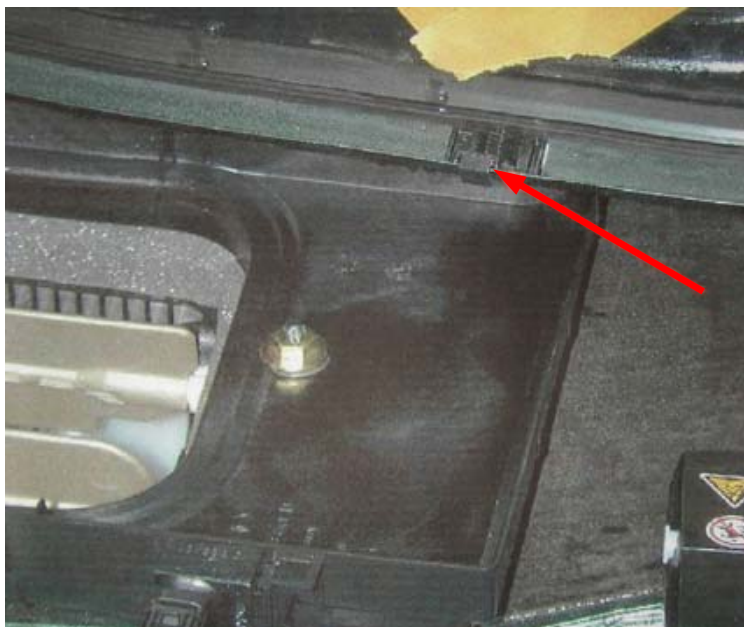
Fig. 2

In the second case, the cause is an incorrectly locked wind deflection plate. This is located in the right-hand windscreen area. Due to this, water runs onto the lower screen carrier, accumulates there on the mounting clip (see Fig. 2), and then drips onto the pollen filter below. After some time, the water get into the air conditioning housing via the filter.
