Audi

A6

Model year from 1998 to 02.2002

Battery charge control lamp illuminates

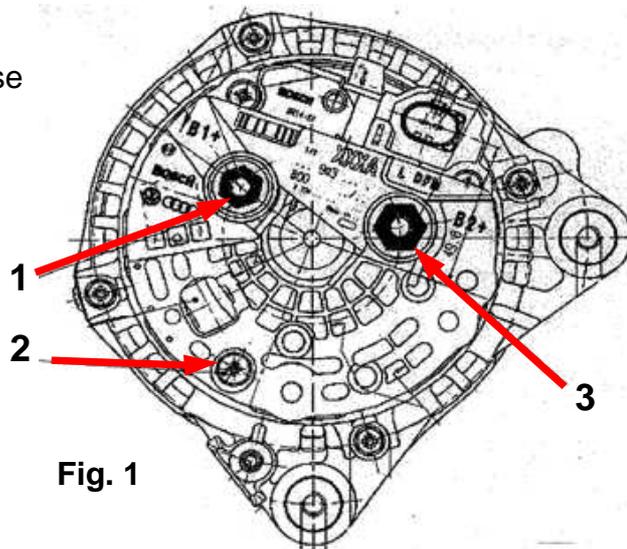
Fig. 1

If there are complaints about the above-mentioned fault, the cause could be a defective voltage regulator. In the case of the A6, regulators made by Bosch and Valeo fitted. In this case, however, only the Bosch regulator is affected. From calendar week 6/2002, an improved regulator was then used. In the event of a complaint, the regulator should be replaced. To do this, proceed as follows:

- Remove the alternator.
- Unscrew the regulator screw (see Fig. 1, Item 2).
- Unscrew the locknuts at the rear of the alternator (see Fig. 1, Items 1 and 3).
- Remove the protector cover.
- Unscrew the phase contact screw (see Fig. 2, Item 4).
- Take off the fastening screws from the regulator and take the regulator out of the generator (see Fig. 2, Item 5).

- Tighten the lock nut (see Fig. 1, Item 3) to a torque of 12 Nm.
- Tighten the lock nut (see Fig. 1, Item 1) to a torque of 32 Nm.
- Tighten the fastening screws of the regulator to a torque of 3 Nm.
- Refit the alternator.
