## **Audi / Seat / VW**

### **With air-conditioning system and compressor without magnetic clutch**

#### **Compressor does not work**

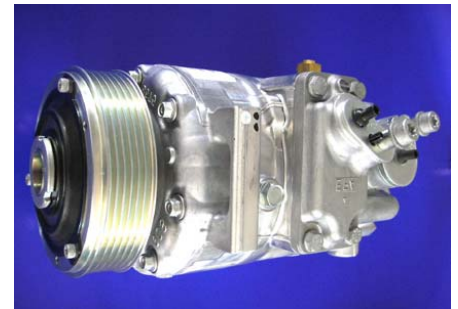
Fig. 1

In the case of the above-mentioned vehicles, compressors without an electric magnetic clutch are sometimes fitted (Fig. 1). Control of the compressor is carried out by an electric control valve (Fig. 2) which is fitted to the compressor and is externally triggered.

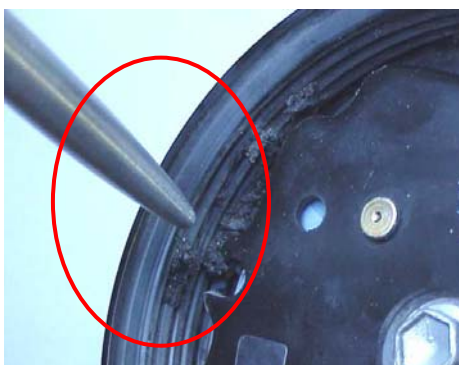
Fig. 3

1. Rubber-abrasion parts are visible on the inside of the pulley (Fig. 3). The compressor shaft is no longer driven. The pulley and the rubber element can be replaced, provided that the compressor can be turned easily.

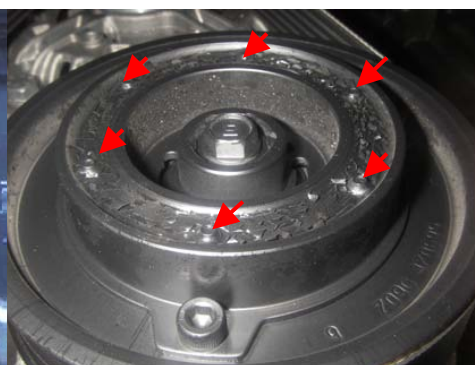
Fig. 4

2. The overload protection has interrupted the frictional connection to the drive plate (Fig. 4). The drive plate and the rubber element can be replaced individually. Prerequisite: The compressor can be turned easily.
3. A triggered torque limiter cannot necessarily be detected visually. In order to check if the limiter has triggered, the compressor shaft must be held still using a suitable tool (Fig. 5), and the pulley simultaneously turned to the left. If the pulley can be turned to the left, the limiter has triggered, and the compressor must be replaced. In the case of the compressor types Sanden PXE 13 and PXE 16, replacement of the torque limiter is not possible.
