Central-locking control unit

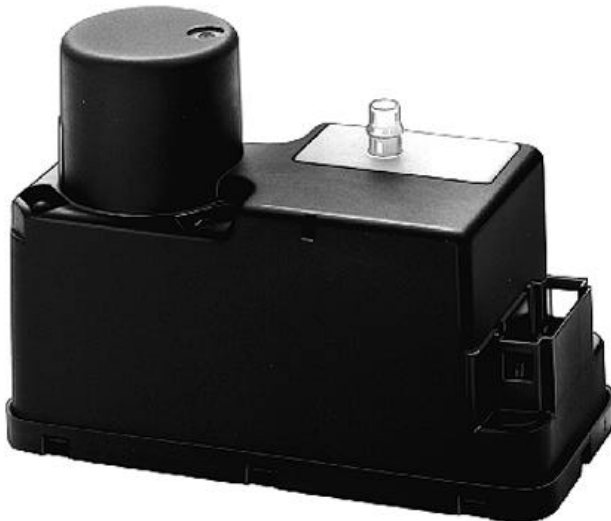
On vehicles with vacuum operated central-locking systems (Audi, VW, Mercedes-Benz) it is possible, that a short time after renewing the central-locking control unit, the system doesn't work.

The cause of the failure is in most cases a leak in the vacuum system.

After renewing the control unit the complete system must be checked for leaks. Mercedes-Benz models W124 / W123 / W201, the vacuum controlled light levelling system, supplied by the vacuum pump, must also be checked for leaks.
