BMW E60

Headlamp fogging Water enters the headlamp

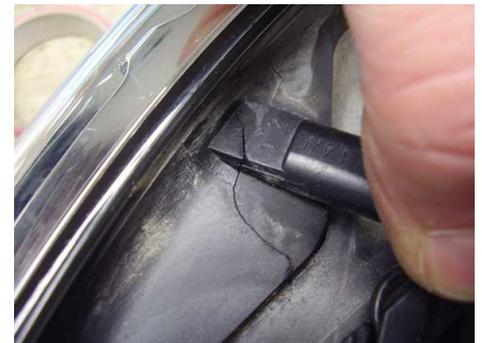
Figure 1

If heavy fogging or, in some cases, increased water ingress is observed inside the headlamp, this may be caused by a crack in the housing of the SML (side marker lamp) (Fig. 1). The SML is partially covered by the CW seal. (Figure 2)

The housing of the SML is damaged.

Cracks may have formed by adverse mechanical stress, for example, if pressure forces occur in this area due to objects or tools: (closing the bonnet without removing tools / objects before).

- Incorrect adjustment of the bonnet.
