BMW 3 Series (E 36) All models with 4-cylinder petrol engine

Noises from the area of the air conditioning compressor.

Bulletin

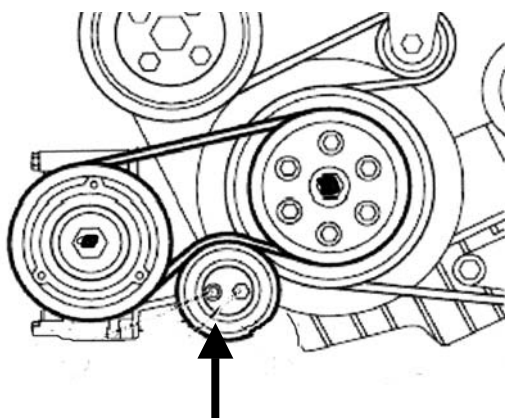
Tensioner pulley

If there are complaints with these vehicles in relation to the noises from the area of the air conditioning system compressor, one possible cause is the tensioner pulley for the drive belt. The ingress of dirt into the tensioner pulley leads to a noise from the area of the compressor developing in certain speed ranges. In the event of hasty diagnosis, these noises may lead to compressor damage being suspected. In order to avoid incorrect diagnoses it is essential that, with the drive belt removed, the tensioner pulley is checked for noises.

During series production, the tensioner pulley was replaced by a modified version (with rear protective cover). If the tensioner pulley is replaced, it should be ensured that the new version is used.
