Bulletin

BMW 3 Series (E46) Model year from 2001 to 2006 All vehicles with automatic air conditioning

Ventilation does not work correctly

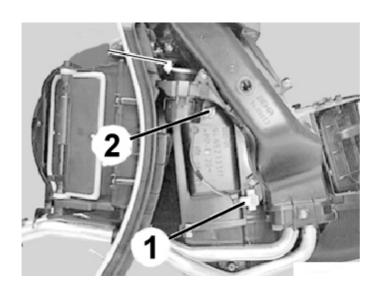
If there are complaints about the above-mentioned fault, the cause could be a faulty temperature sensor on the evaporator. The faulty temperature sensor causes the evaporator to ice up. In this case, the evaporator-temperature sensor must be replaced. This is located in the driver footwell (see illustration, item 1). Before removing the sensor however, a resistance measurement should be carried out. Remove the plug-connection (see illustration, item 2) and measure on the contacts. At an ambient temperature of 25 °C, the nominal value must be between 8.8 and 9.2 kiloohms.
