BMW 3 series (E46) All Touring models Model years 2001-2005

Licence plate lights fail

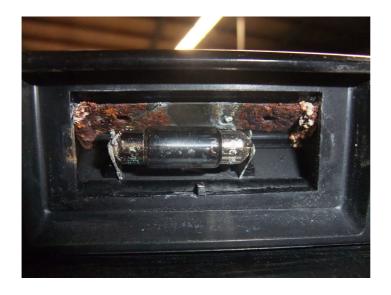
If a customer complains about the above error, this is not necessarily caused by the light source. High levels of humidity in the lights corrode the contacts (see Fig. 1). Capillary action in the cables can then bring water into the contact switch. This generally leads to corrosion in the switch, which prevents sufficient contact. The trunk lid may sporadically lock and unlock. In this case, proceed as follows:
