## **BMW 5serie (E39) all models with climate control**

### **Intermittent heating of the foot well.**

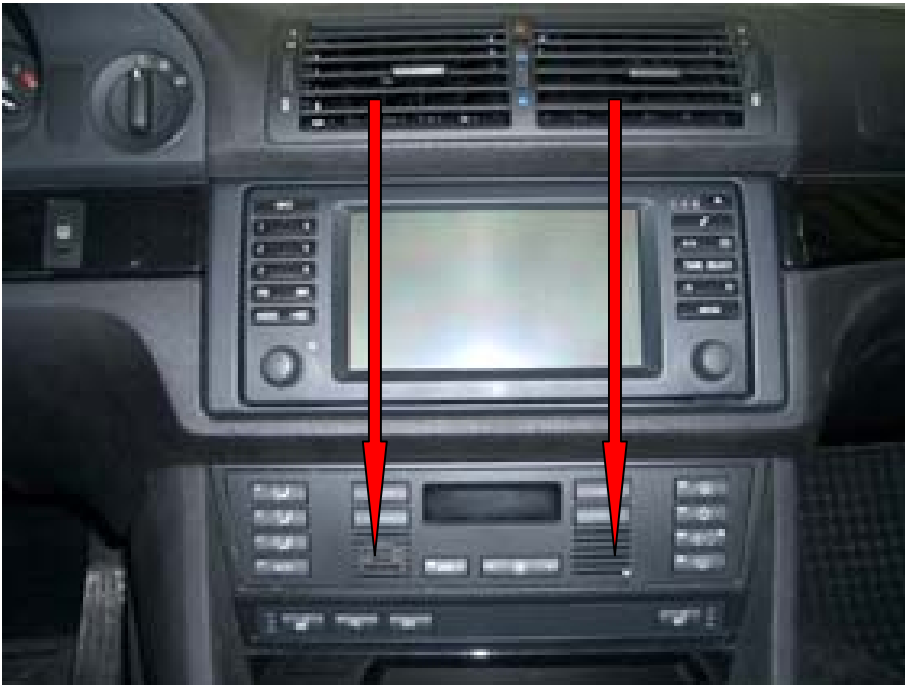
If, on this vehicle is mentioned that the foot well is intermittently heated, a possible cause could be the following: If the temperature setting is cold and the airflow through the centre vents is chosen, it is possible that the down draught of cold air is sucked in by the small blower of the interior temperature sensor (picture). Due to this the climate control recognises too low temperature and increases the heat, especially to the foot well air outlet.

To prevent this process, the temperature setting should be higher, an other air outlet should be chosen or the vent position changed so the air is not directly downwards.
