BMW E 31, E 38, E 39, E 36

Poor radio reception.

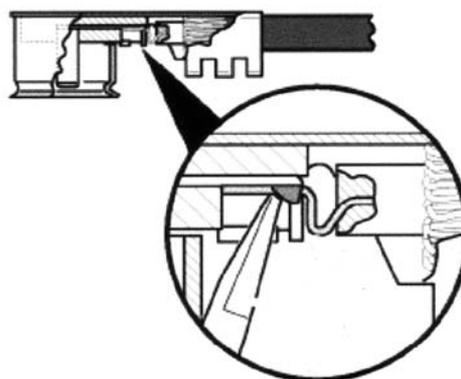
Fig. 3

If there are complaints about poor radio reception with these vehicles, one possible cause is an interruption in the angled aerial plug on the radio. Excessive mechanical strain can cause the wire inside the aerial cable to break near the connection point to the aerial plug. To eliminate the fault, a new aerial plug has to be installed. To do this proceed as follows:

- Remove¹ the radio and pull the aerial cable off.
- Nip off the old aerial plug.
- Insulate the aerial cable (Fig. 1).
- Shape the inner wire (Fig. 2).
- Push the new aerial plug on and attach to the inner wire using one solder point (Fig. 3).
- Crimp the cable guide and strain relief using the crimping tool and put the plastic cover on the aerial plug (Note: make sure that the inner wire and the shield do not come into contact with one another).
- Install the components in reverse order and check their function.
