BMW E39 build year till 02/1996

Intermittent non function of the instrument cluster.

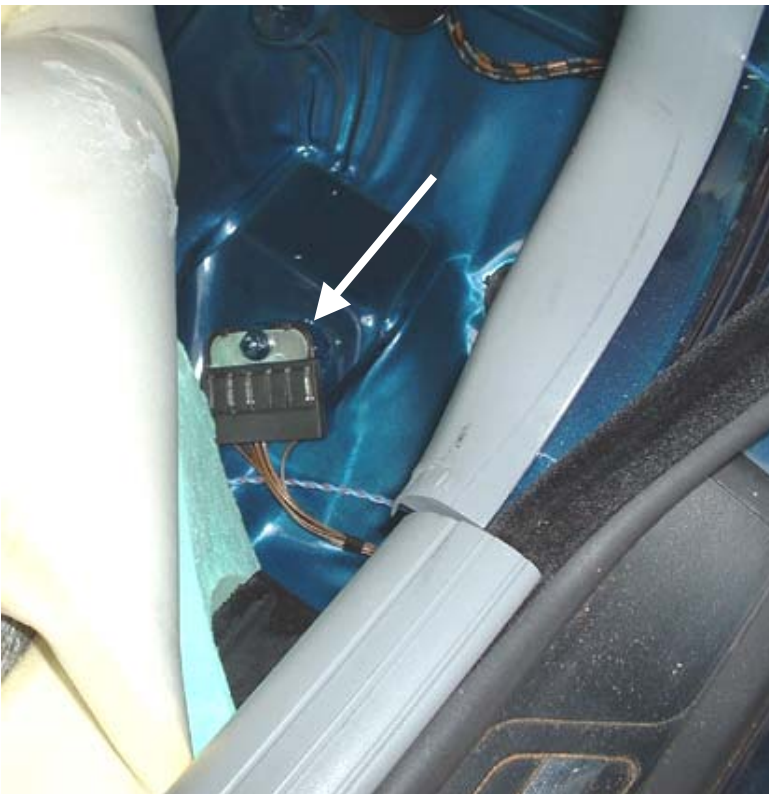
If, on this vehicle, the instrument cluster is functioning intermittently, a possible cause could be a faulty ground/earth connection. To rectify the problem the supply voltage and ground/earth connection should be checked. Mainly the fault is in the ground/earth point for the instrument cluster on the floor in the right front foot well (picture).
