BMW E46 **build year 2/98 - 4/99**

Condense water in the footwell

Bulletin

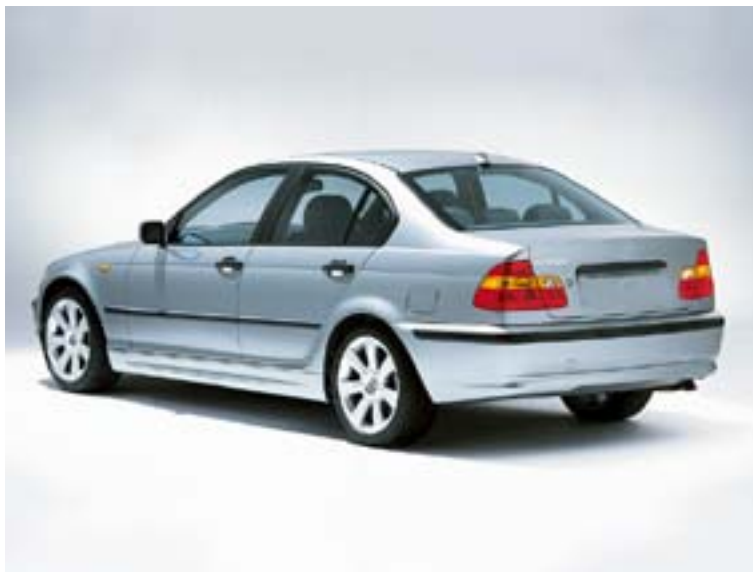
On the above mentioned vehicles with climate control, it can occur, that condense water drips into the front passenger footwell when the a/c-system is running. This is due to a faulty routing of the condensation drain pipes therefore condensation isn't drained correctly. Remedy can be made here by a correction of the tube routing. It may be necessary to dismantle the evaporator unit for a better accessibility.
